# Comprehensive Agreement No.1

## Fifth Annual Report

BIG CHINO SUB-BASIN  
WATER MONITORING PROJECT  
PRESCOTT - PRESCOTT VALLEY - SRP

# Big Chino Sub-basin Water Monitoring Project

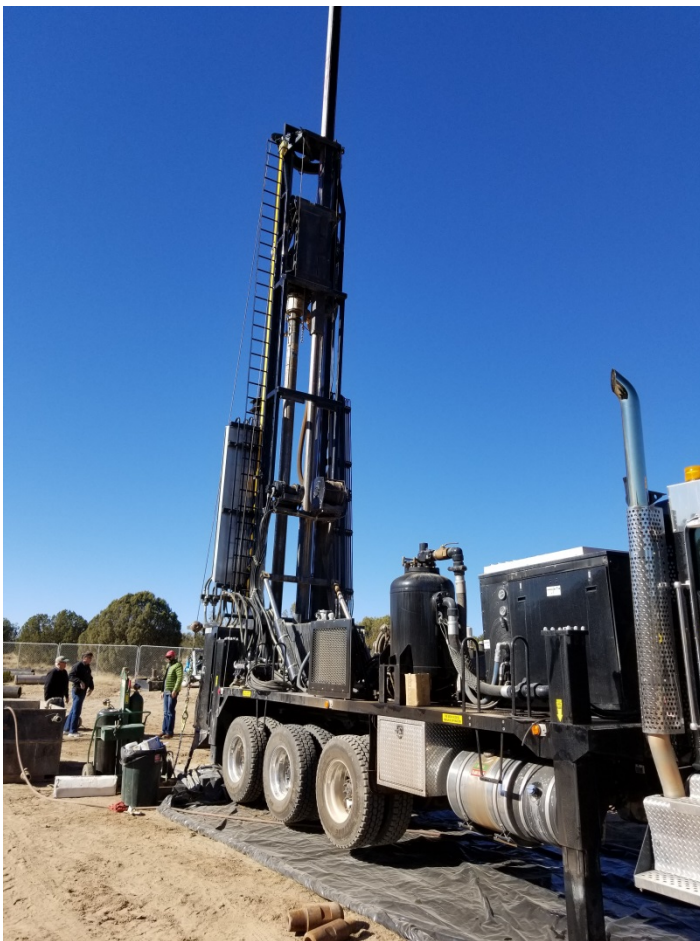
Drilling well MW-4d (March 4, 2018)

- On July 25, 2017, the Parties executed Phase 2 Scope of Work (Contract 2016-296A1) with Southwest Groundwater Consultants to design seven (7) new monitoring wells, develop bid documents for drilling contract and provide drilling oversight, aquifer testing and data analysis.
- On November 2, 2017, the Parties executed a contract with Yellow Jacket Drilling (Contract # 2018-114) to drill seven (7) new monitoring wells as defined in the Data Collection and Monitoring Plan and complete aquifer testing at three (3) of those new wells. Well drilling began on January 22, 2018. Drilling and aquifer tests were complete by the end of June, 2018.

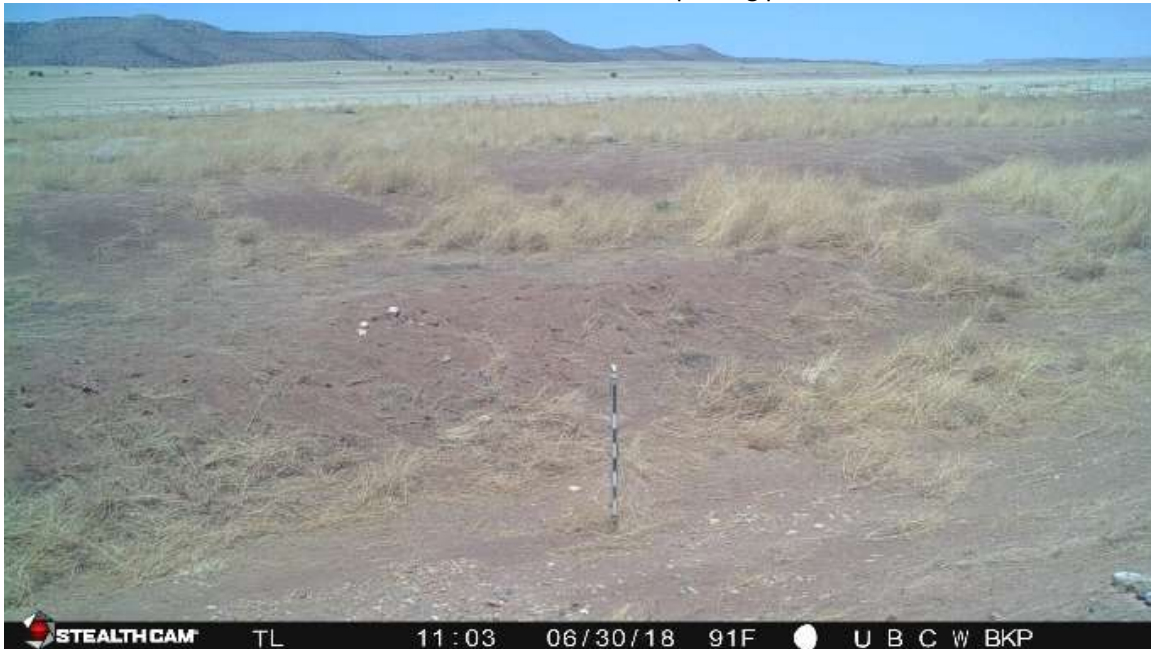
FIGURE 4. UBCW IMAGE DATA

UBCW at the end of the 2018 reporting period:

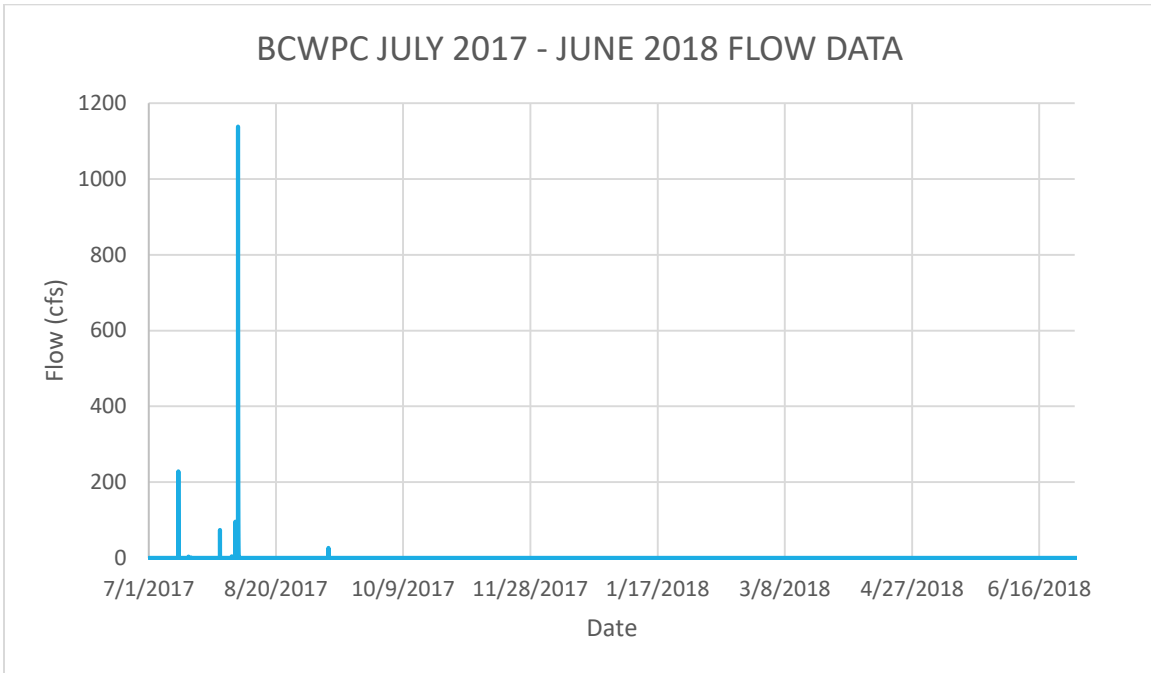
FIGURE 5. BCWPC JULY 2017 – JUNE 2018 ANNUAL FLOW EVENTS

Eight (8) events with measurable ephemeral flow were recorded at BCWPC during the 2018 annual monitoring period. UBCW responded to monsoon related precipitation events only and most of the accumulated flows observed were small. Peak discharge for the year was 1138 cfs observed on 8/5/2017. The 7/12/2017 event was the longest lasting event observed at the site for the year with a duration of 15.25 hours, resulting in an estimated total flow volume of 42.11 AF or 16% of the annual volume at the site. The 8/5/2017 event resulted in the largest estimated volume at 201 AF or 78% of the annual volume at the site. The total estimated volume recorded at the site for the 2018 reporting period was 257 AF. BCWPC flow events, durations, and total estimated volumes for the 2018 reporting period are outlined in Table 3 and Figures 5-7.

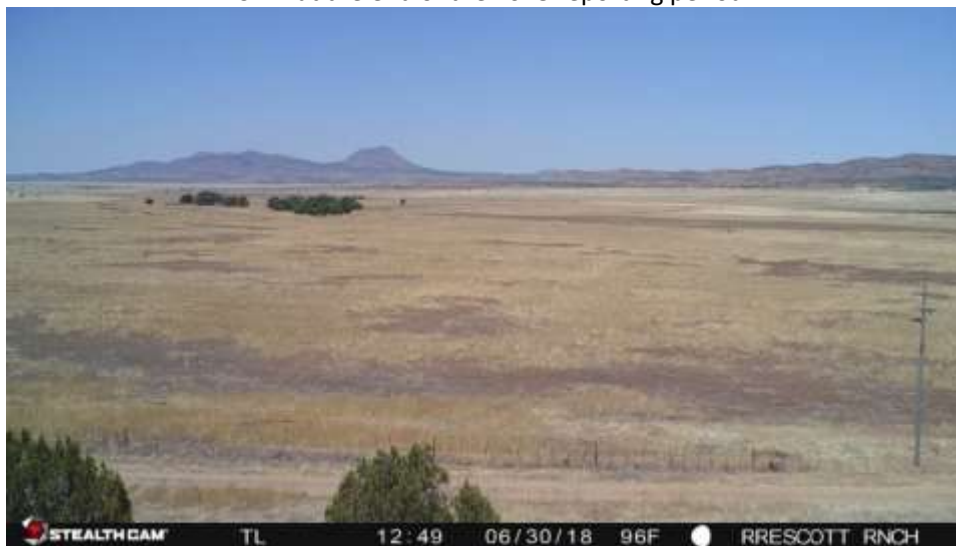
FIGURE 8. BCWR IMAGE DATA

At BCWR, rainfall was observed on fifty-seven (57) days. Snowfall was visible on two (2) days, and snow accumulation was visible for two (2) days. None of the observed events resulted in water pooling at the surface. BCWR site images from the July 2017 – June 2018 reporting period can be seen in Figure 8 below.

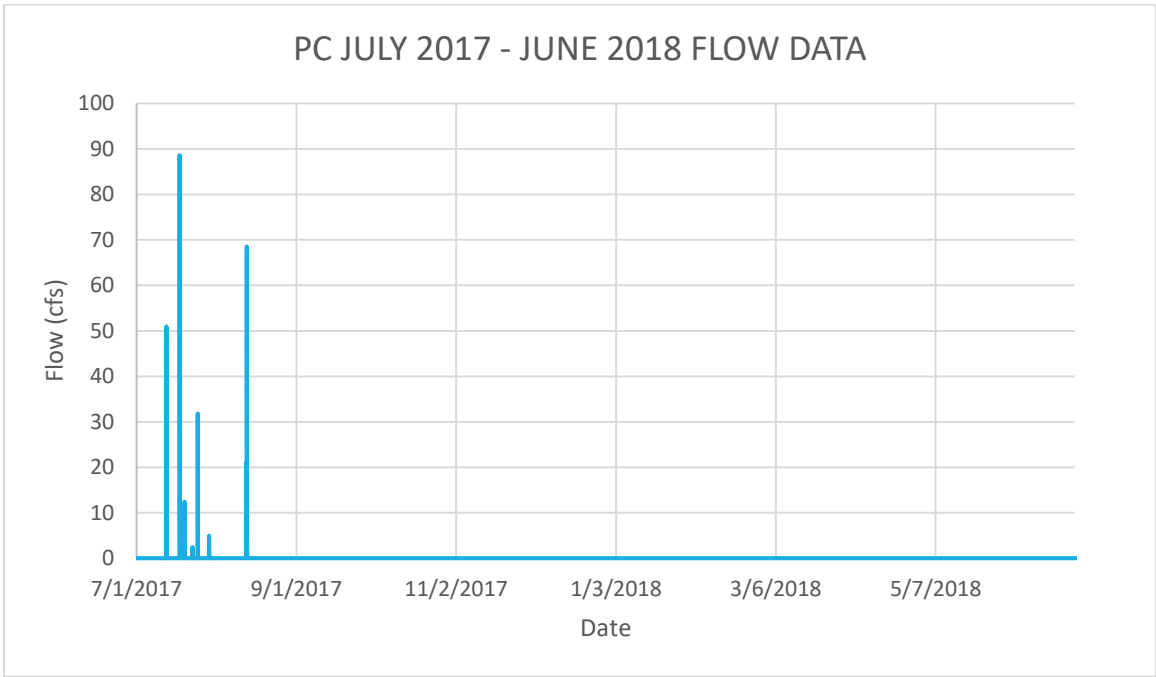
FIGURE 9. PC JULY 2017 – JUNE 2018 ANNUAL FLOW EVENTS

Seven (7) events with measurable ephemeral flow were recorded at PC during the 2018 annual monitoring period. PC responded to monsoon related precipitation events only and all of the accumulated flows observed were small. Peak discharge for the year was 89 cfs observed 7/17/2017. The 8/12/2017 event was the longest lasting event observed at the site for the year with a duration of 12.25 hours, resulting in the largest volume single flow event with a total estimated volume of 11 AF or 52% of the annual volume at the site. The total estimated volume recorded at the site for the 2018 reporting period was 21 AF. PC flow events, durations, and total estimated volumes for the 2018 reporting period are outlined in Table 4 and Figures 9-11.

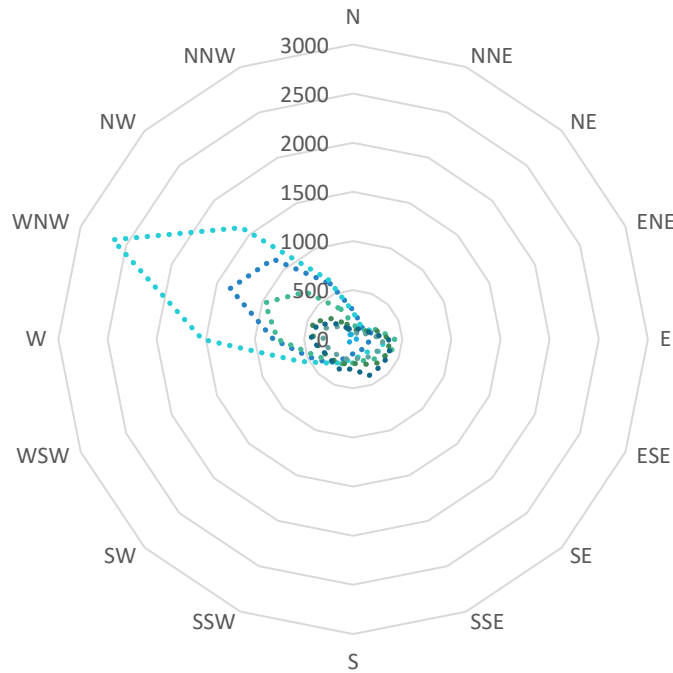
FIGURE 12. GWC JULY 2017 – JUNE 2018 WIND ROSE

- 11.73” of precipitation, excluding seasonal snow water equivalent, was observed during the 2018 reporting period
- Wind speed ranged from a minimum of 0 mph on 1/9/2018 to a maximum of 17.7 mph on 12/7/2017, with the highest average wind speeds in the spring and the lowest in the fall
- The predominant wind direction was WNW with higher velocity winds tending from the NNE
- Air temperature ranged from a maximum of 94.4°F in July 2017 to a minimum of 10.3°F in February 2018
- The peak average relative humidity was 49.78% in July 2017

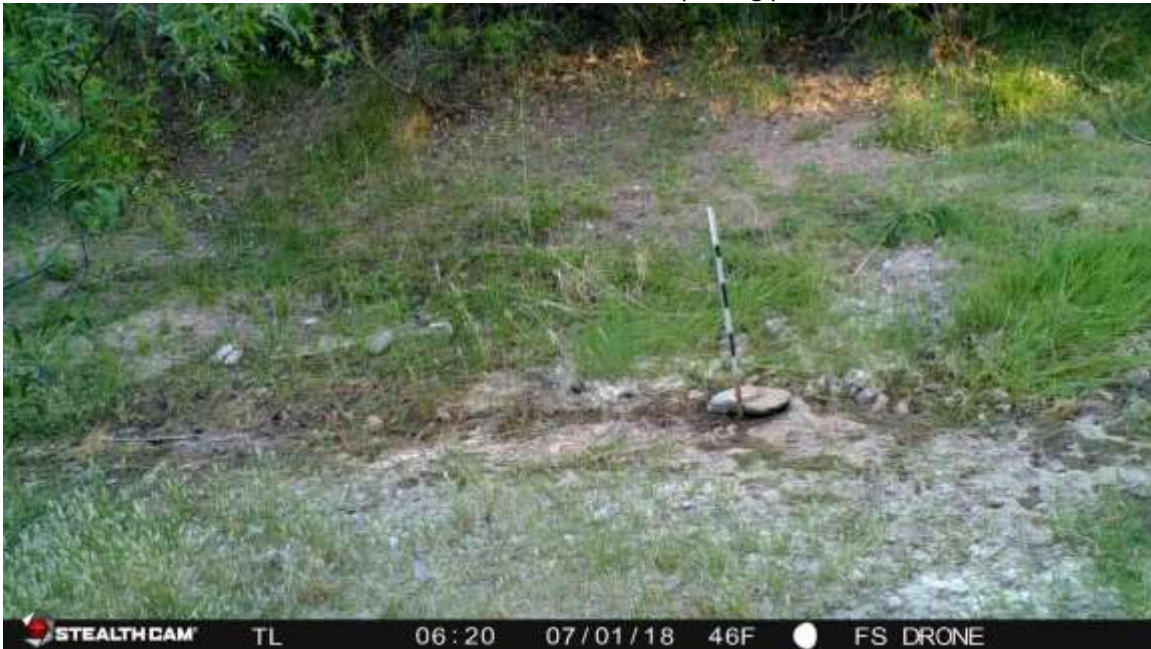
FIGURE 21. UWCFS IMAGE DATA

The flume was permanently removed after being damaged on December 22, 2016. Following the removal of the flume, there are no estimates of flow for this site, other than visual wet/dry conditions. UWCFS site images are shown in Figure 21 below.

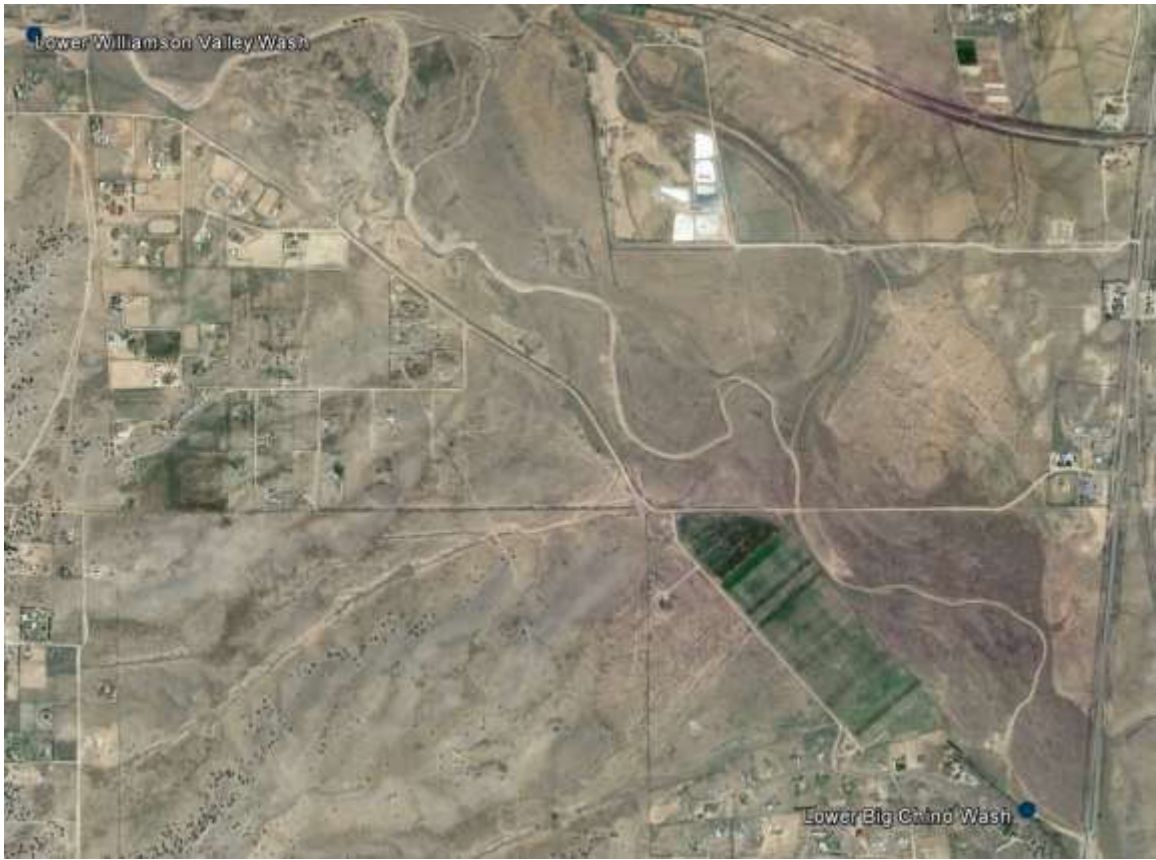
FIGURE 32. AERIAL IMAGE OF WILLIAMSON VALLEY WASH CONFLUENCE WITH BIG CHINO WASH BETWEEN LWVW AND LBCW

It is important to note that LBCW is 2.5 miles southeast of LWVW, and approximately 3.7 river miles downstream of the LWVW site due to a series of meandering bends. The channel behaved as it has in the past several years, where larger accumulated flows are observed at LWVW than LBCW. See Figure 32 below for an aerial image of the sites.

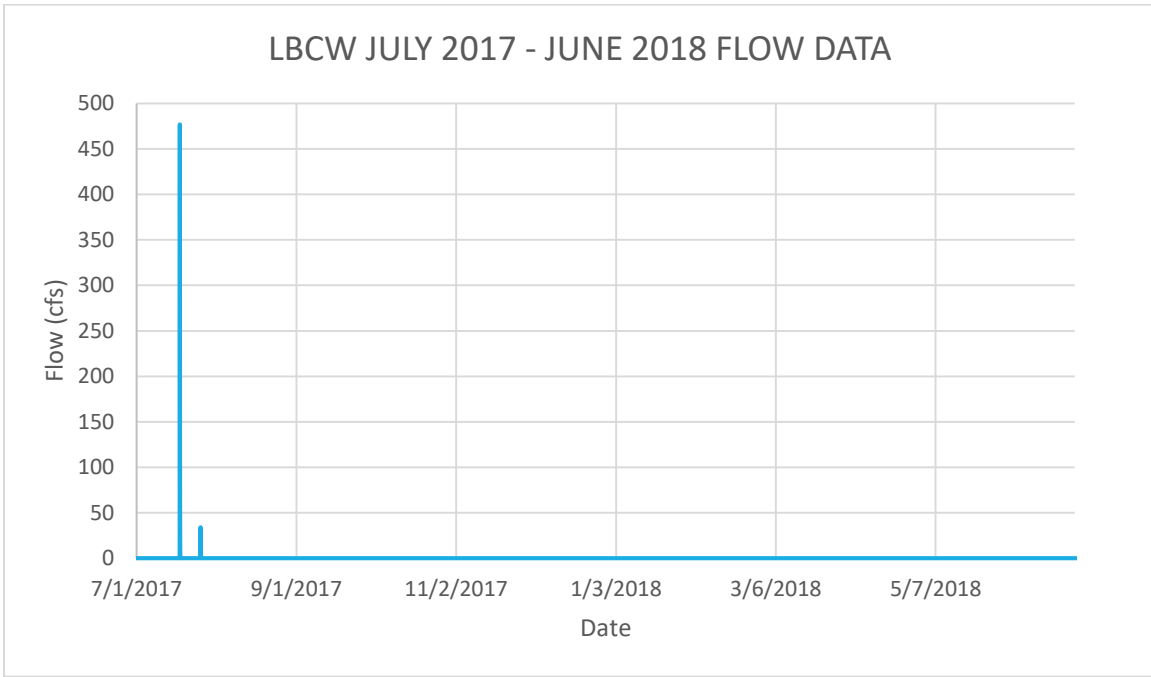
*FIGURE 33. LBCW JULY 2017 – JUNE 2018 ANNUAL FLOW EVENTS*

Two (2) events with measurable ephemeral flow were recorded at LBCW during the 2018 annual monitoring period. LBCW responded only to monsoon related precipitation events only. Peak discharge for the year was 476.99 cfs observed on 7/17/2017, which was also the longest lasting accumulated flow event of the year with a duration of 12.5 hours, resulting in the largest single flow event with a total estimated volume of 83.72 AF or 95% of the annual volume at the site. The total estimated volume recorded at the site for the 2018 reporting period was 88.55 AF. LBCW flow events, durations, and total estimated volumes for the 2018 reporting period are outlined in Table 9 and Figures 32-35.

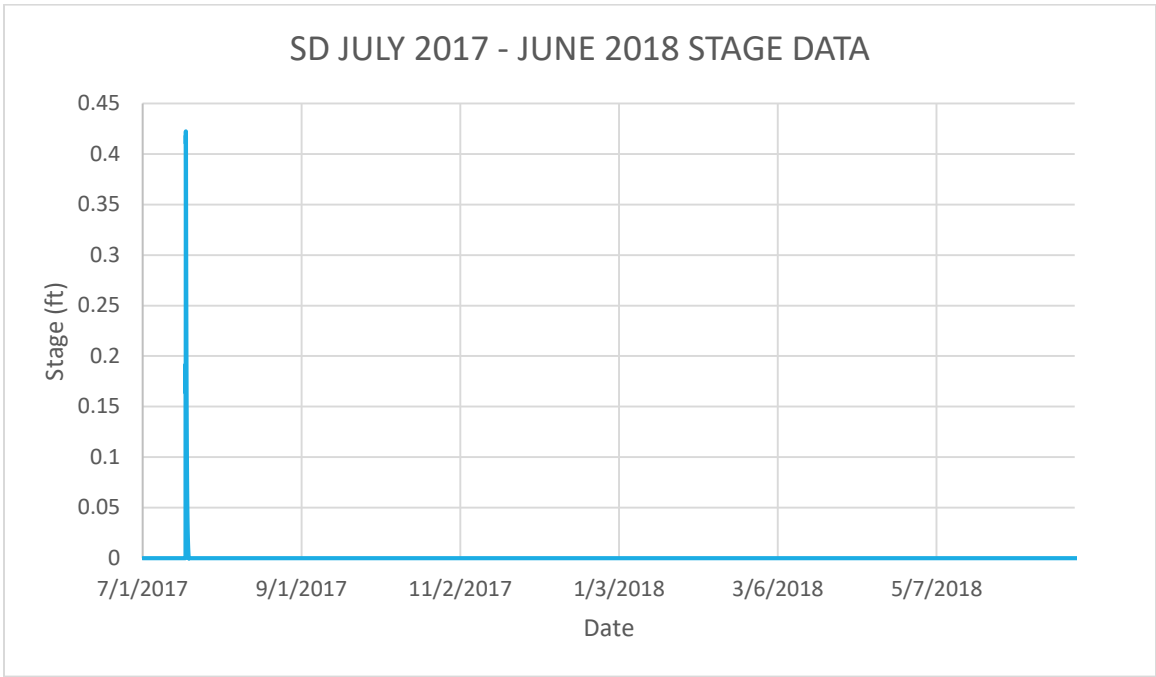
FIGURE 36. SD JULY 2017 – JUNE 2018 ANNUAL EVENTS

One (1) event was observed at SD during the 2018 annual monitoring period. SD responded only to monsoon related precipitation events. Standing surface was visible behind the dam starting on 8/6/2016 up to the start of the 2018 reporting period. Stage represents the water depth of water spilling over the SD structure crest. There is no stage to discharge relation for the site, therefore no flow data is assumed. SD events, durations, and peak stages for the 2018 reporting period are outlined in Table 10 and Figures 36-38.
