**Reconnaissance Watershed Analysis on the  
Upper and Middle Verde Watershed**

June 30, 2002

Loyd O. Barnett and Richard H. Hawkins  
School of Renewable Natural Resources  
University of Arizona  
Tucson, Arizona.

funded by  
**Arizona Rural Watershed Initiative**

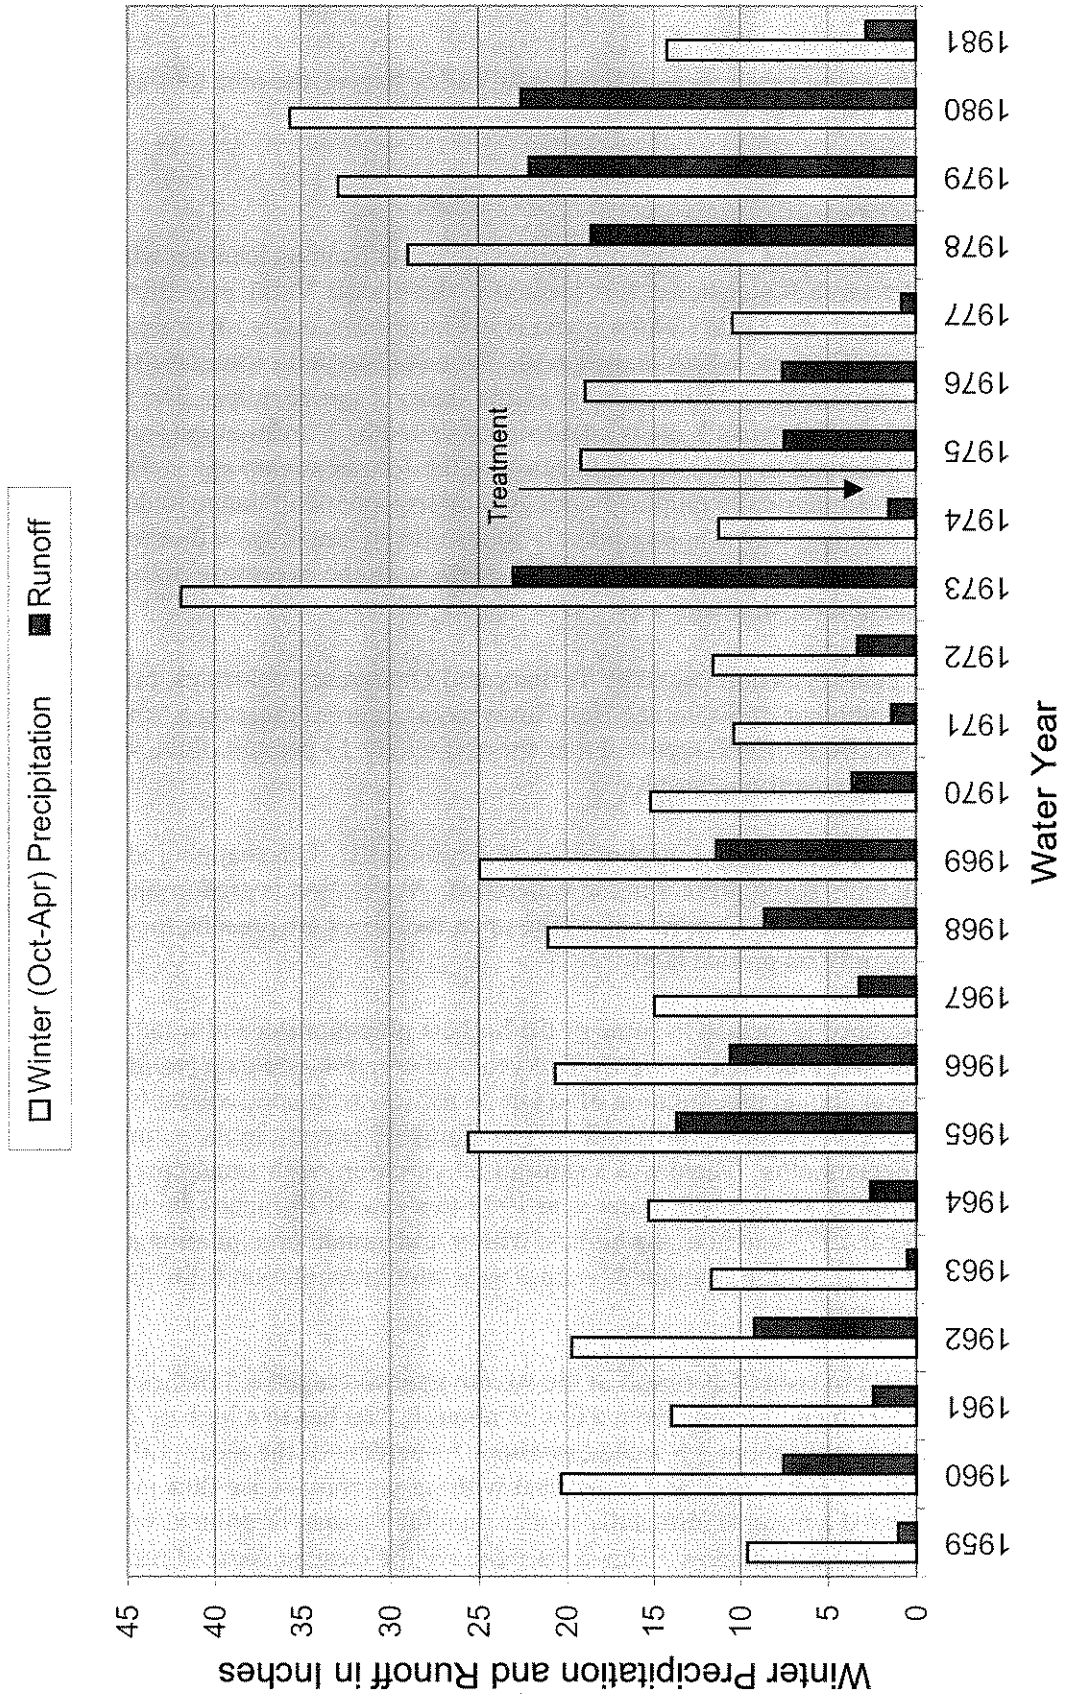
Fig. A-3. Beaver Creek Watershed 8 Winter Precipitation and Annual Runoff

Figure A-3 illustrates seasonal precipitation and runoff for Watershed 8. Runoff is produced very predominantly by winter precipitation -- rain, rain on snow events, and snowmelt. Figure A-4 illustrates the water balance in another manner -- total precipitation is divided into that which runoff and the residual which is a combination of evapotranspiration plus any subsurface movement not detected at the stream gage. It is believed that there is only a limited amount of subsurface flow. The evapotranspiration component varies depending on the patterns of precipitation and the availability of moisture throughout the growing season.
