Second Annual Report

FY15
(July 1, 2014 – June 30, 2015)

BIG CHINO SUB-BASIN
WATER MONITORING PROJECT
PRESCOTT - PRESCOTT VALLEY - SRP

Big Chino Sub-basin Water Monitoring Project Monsoon Season Report: July 1 – September 30

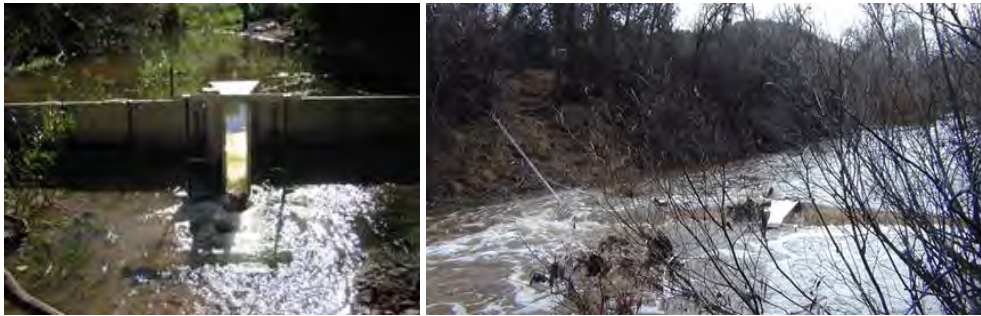
Walnut Creek Flume after installation, looking upstream (October, 2014) and after storm damage, looking upstream (January, 2015).

On January 30, 2015, a high-flow event significantly damaged the flume. The flume was reinstalled on 6/22/2015 with earthen, rather than metal, wing walls. This design feature allows the earthen wing walls to be eroded by high flows and pass around the flume rather than push the flume along with the wing walls. Following a large event in the future, the flume can be easily reinstalled.

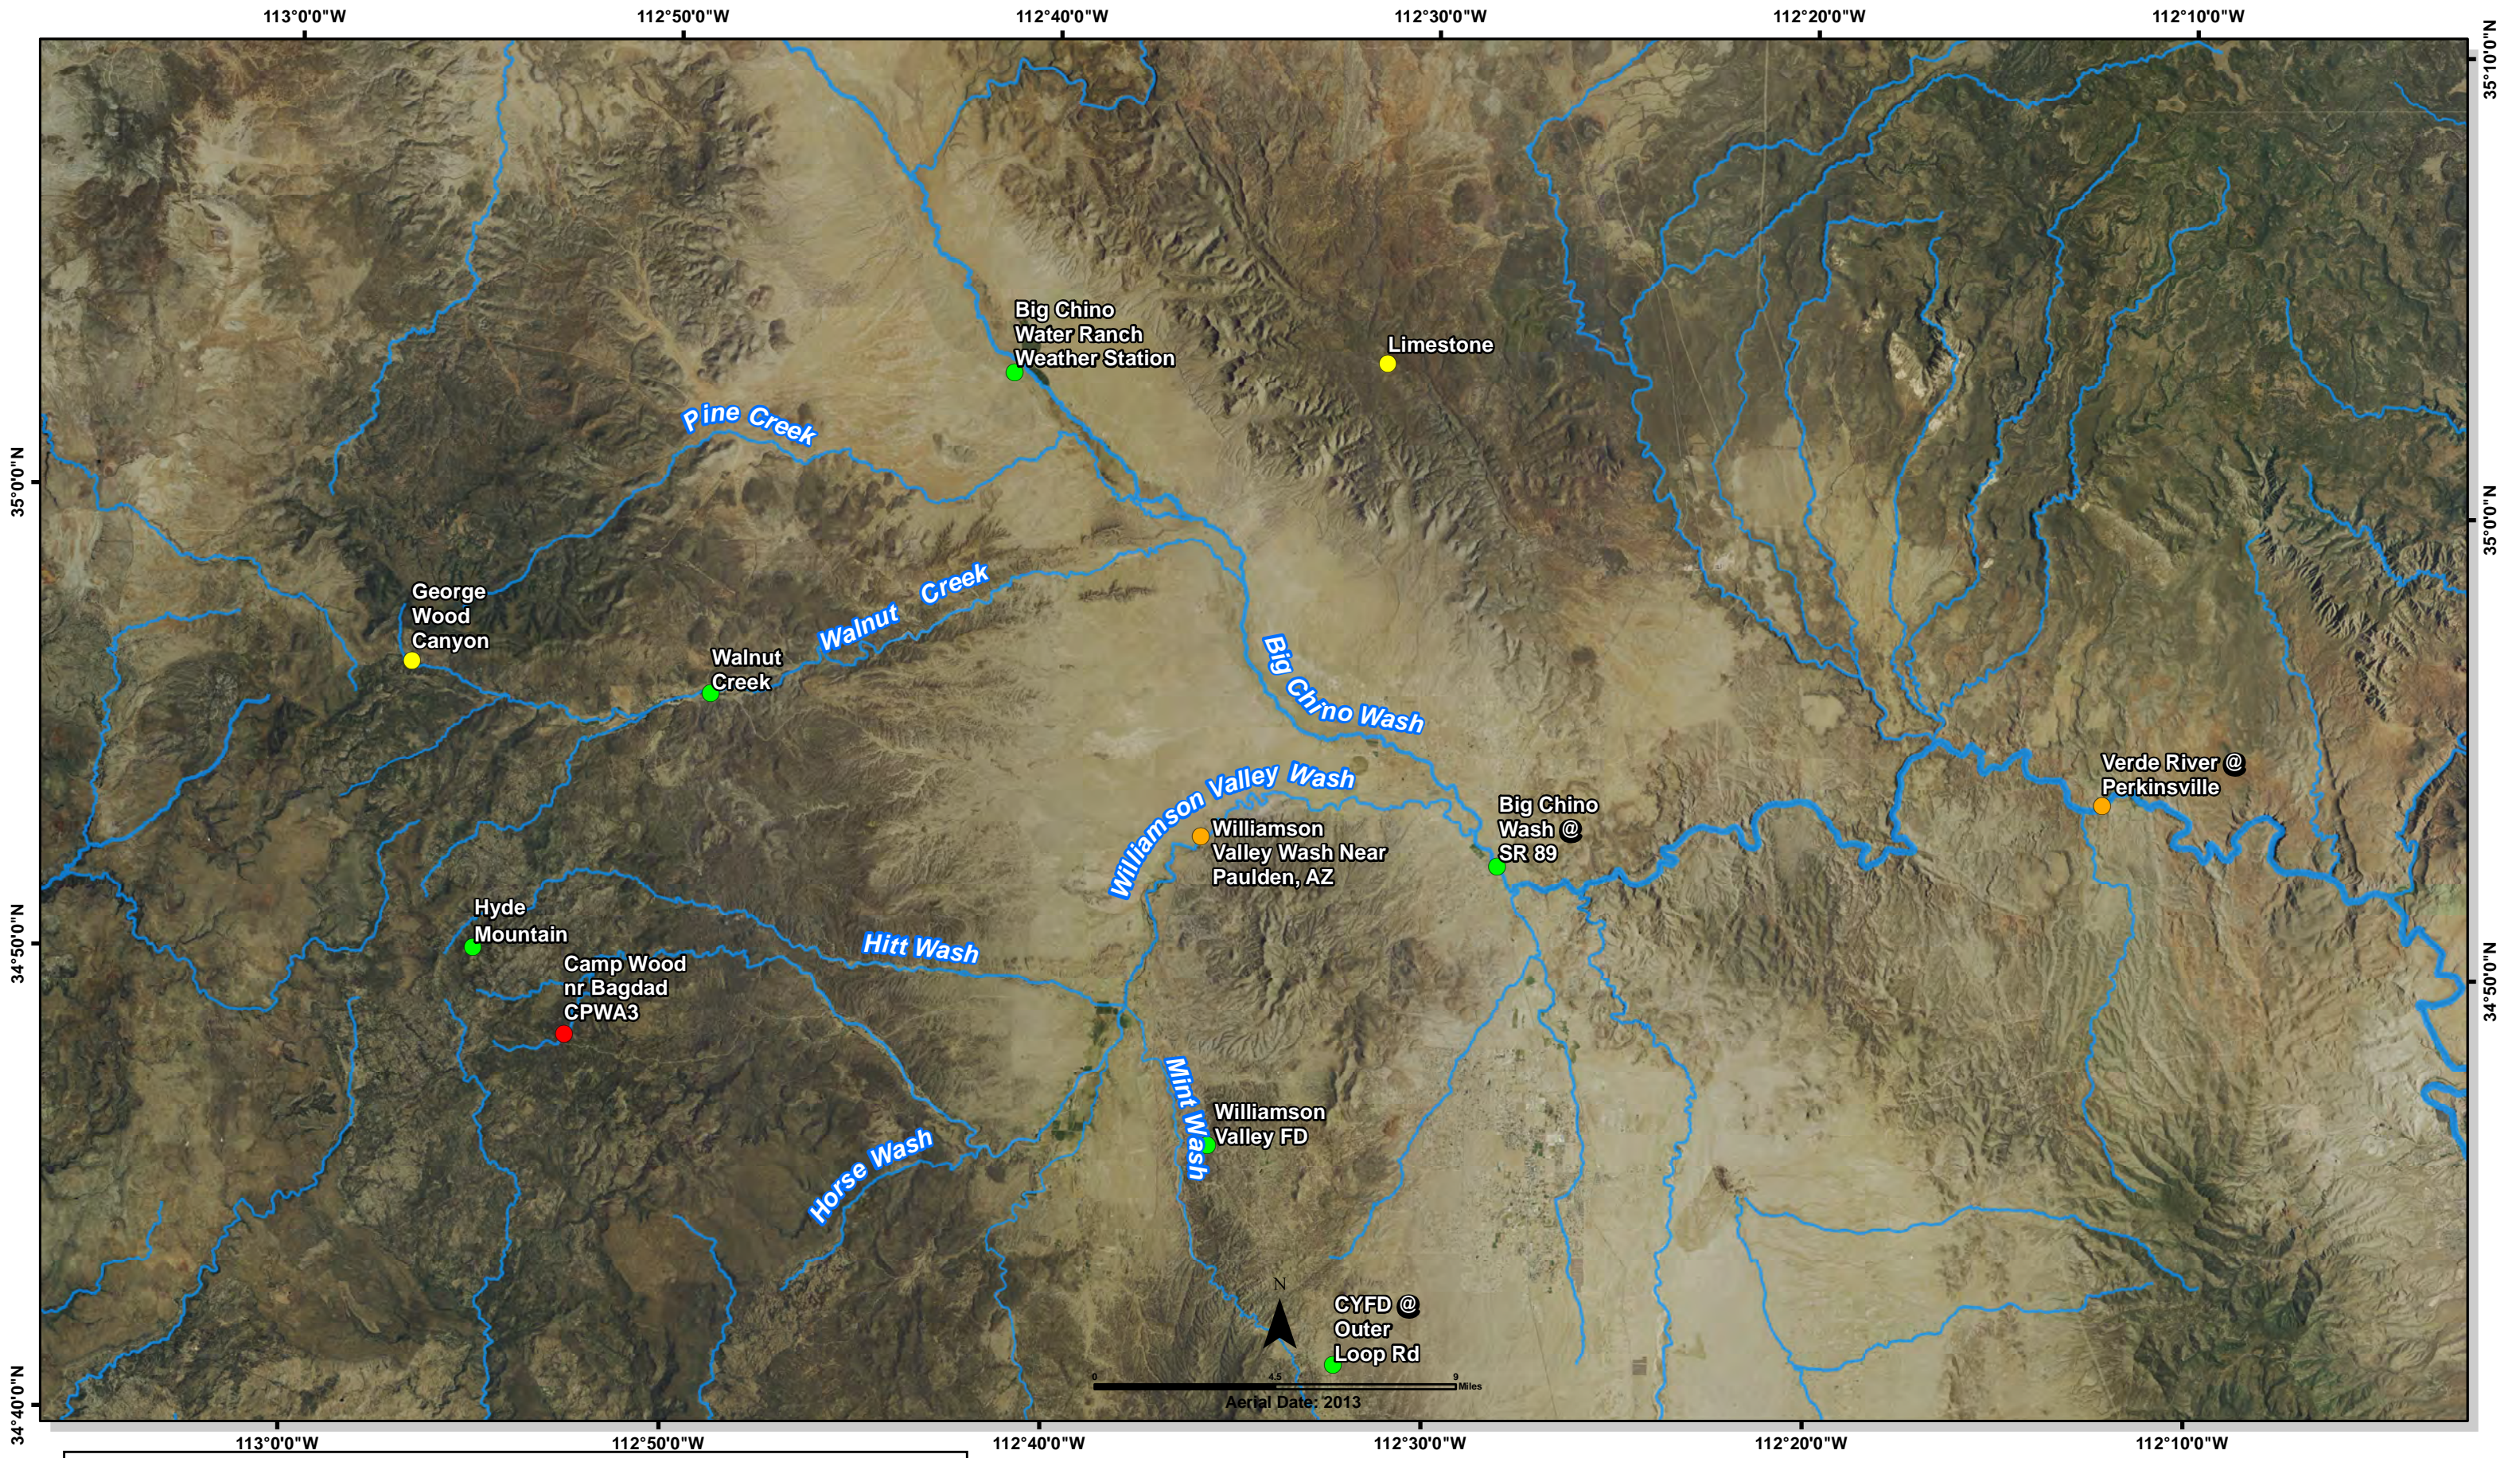
Map 5
Big Chino Area
Weather Stations

- Yavapai County Flood Control District Weather Station
- National Weather Service Hydrometeorological Automated Data System Station
- USGS Weather Station
- Proposed Weather Station

The CA#1 Monitoring Committee identified a high elevation location for a full-service weather station on the southwestern flank of Juniper Mesa at George Wood Canyon. Installation and operation of this site was contracted with SRP in Amendment Two to the Independent Contractor Agreement. This site will also incorporate a “Snowtopography” gage to help monitoring snow conditions on the watershed. Snow condition data will provide critical information for estimating runoff characteristics after a precipitation event. This data will inform the CA#1 Committee and SRP Field Services personnel about the possibility of sustained runoff conditions and opportunities for making direct stream measurements. A land access agreement is currently waiting for approval from the Prescott National Forest. The equipment is in storage and ready to be installed pending approval of the agreement. Table 6 lists information on these new sites and Map 5 shows their location.

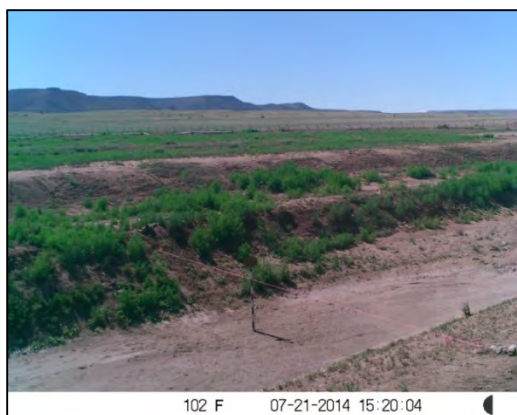
Figure 1. Upper Big Chino Wash tagline reference.

Data processing of stage values and rating curves were completed using Aquarius (version 3.5) time series software. Stage values (feet) collected from the upstream transducer serve as the primary data source (downstream transducer serve as secondary). Offsets to stage values were applied based on the depth of the transducer below stream channel and then compared with visual determination of stage values from flowtopography images. For instances when the event gage was obstructed or missing from the flowtopography images, stage level overlays were created using a tag line reference at each location (see Figure 1 and Figure 2).

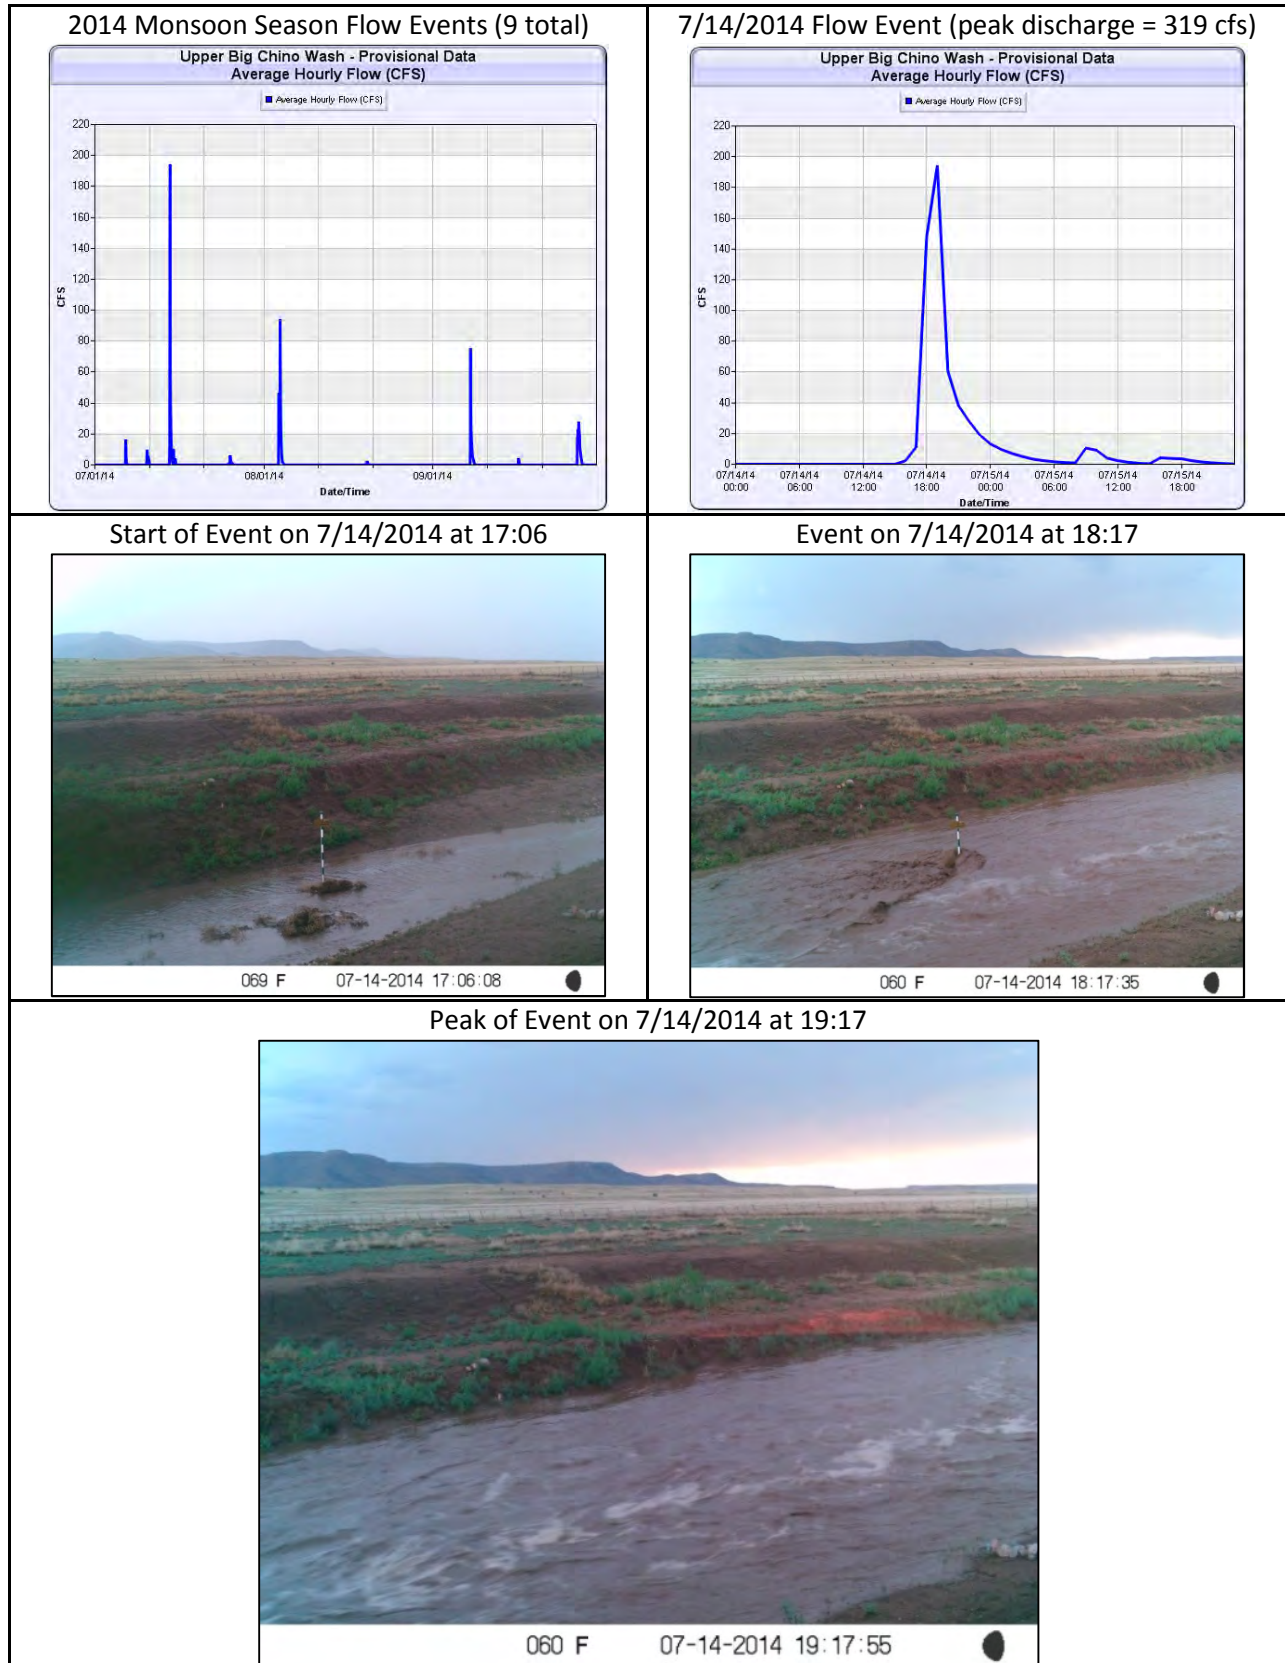
Figure 4: Upper Big Chino Wash Hydrographs and Flowtography Flow Event Images

- Repaired and replaced the two event gages that were knocked over during the 7/14/2014 flow event
- Replaced filter screen on upstream event gage and cleared vegetation from banks that obstruct flowtopography view
- Took photos with tagline (reference) to determine stage level in images without event gage or with obstructed view of event gage

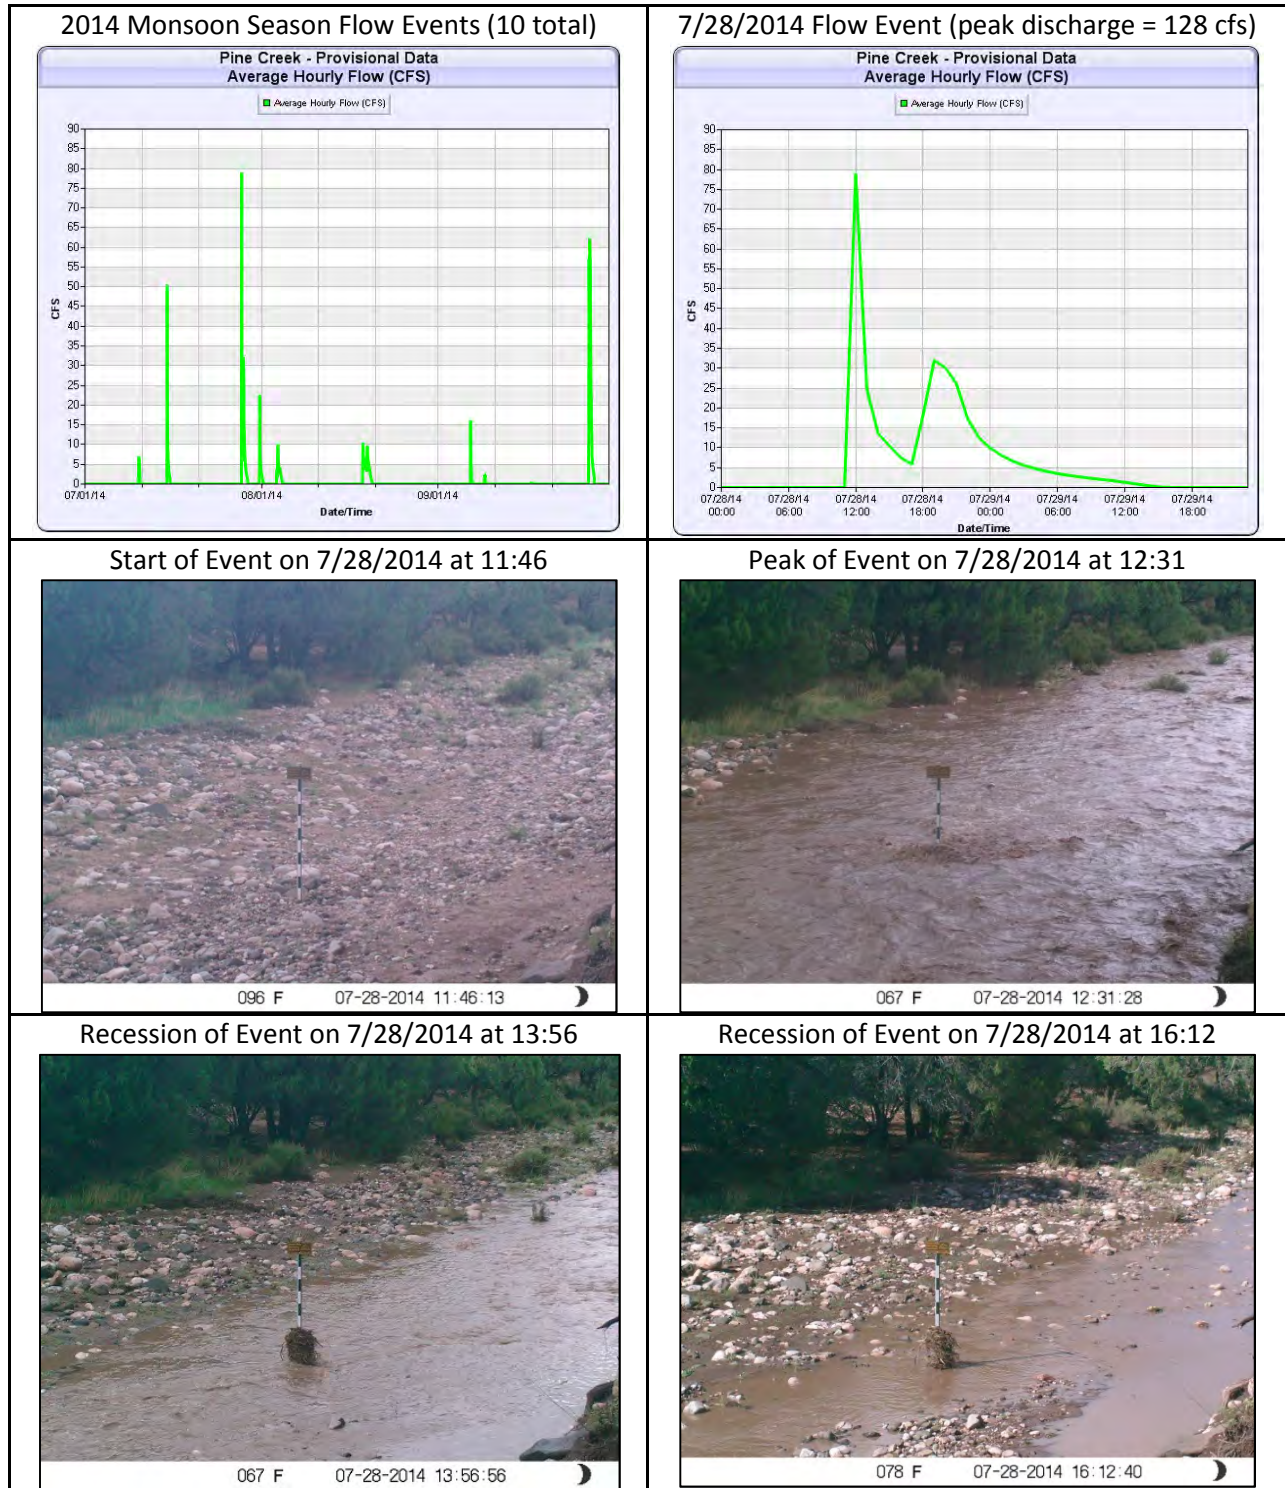
Figure 6: Pine Creek Hydrographs and Flowtopgraphy Flow Event Images

A total of 10 flow events were recorded at Pine Creek (PC) location during the period from July 1, 2014 through September 30, 2014. Peak discharge during events ranged from 0.51 CFS on 9/16/2014 to 84.7 CFS on 9/27/2014. Total volume of each event ranged from 0.05 AF to 46.49 AF, respectively. A total volume of 120.47 AF was estimated to flow through the PC location during the 2014 monsoon season.

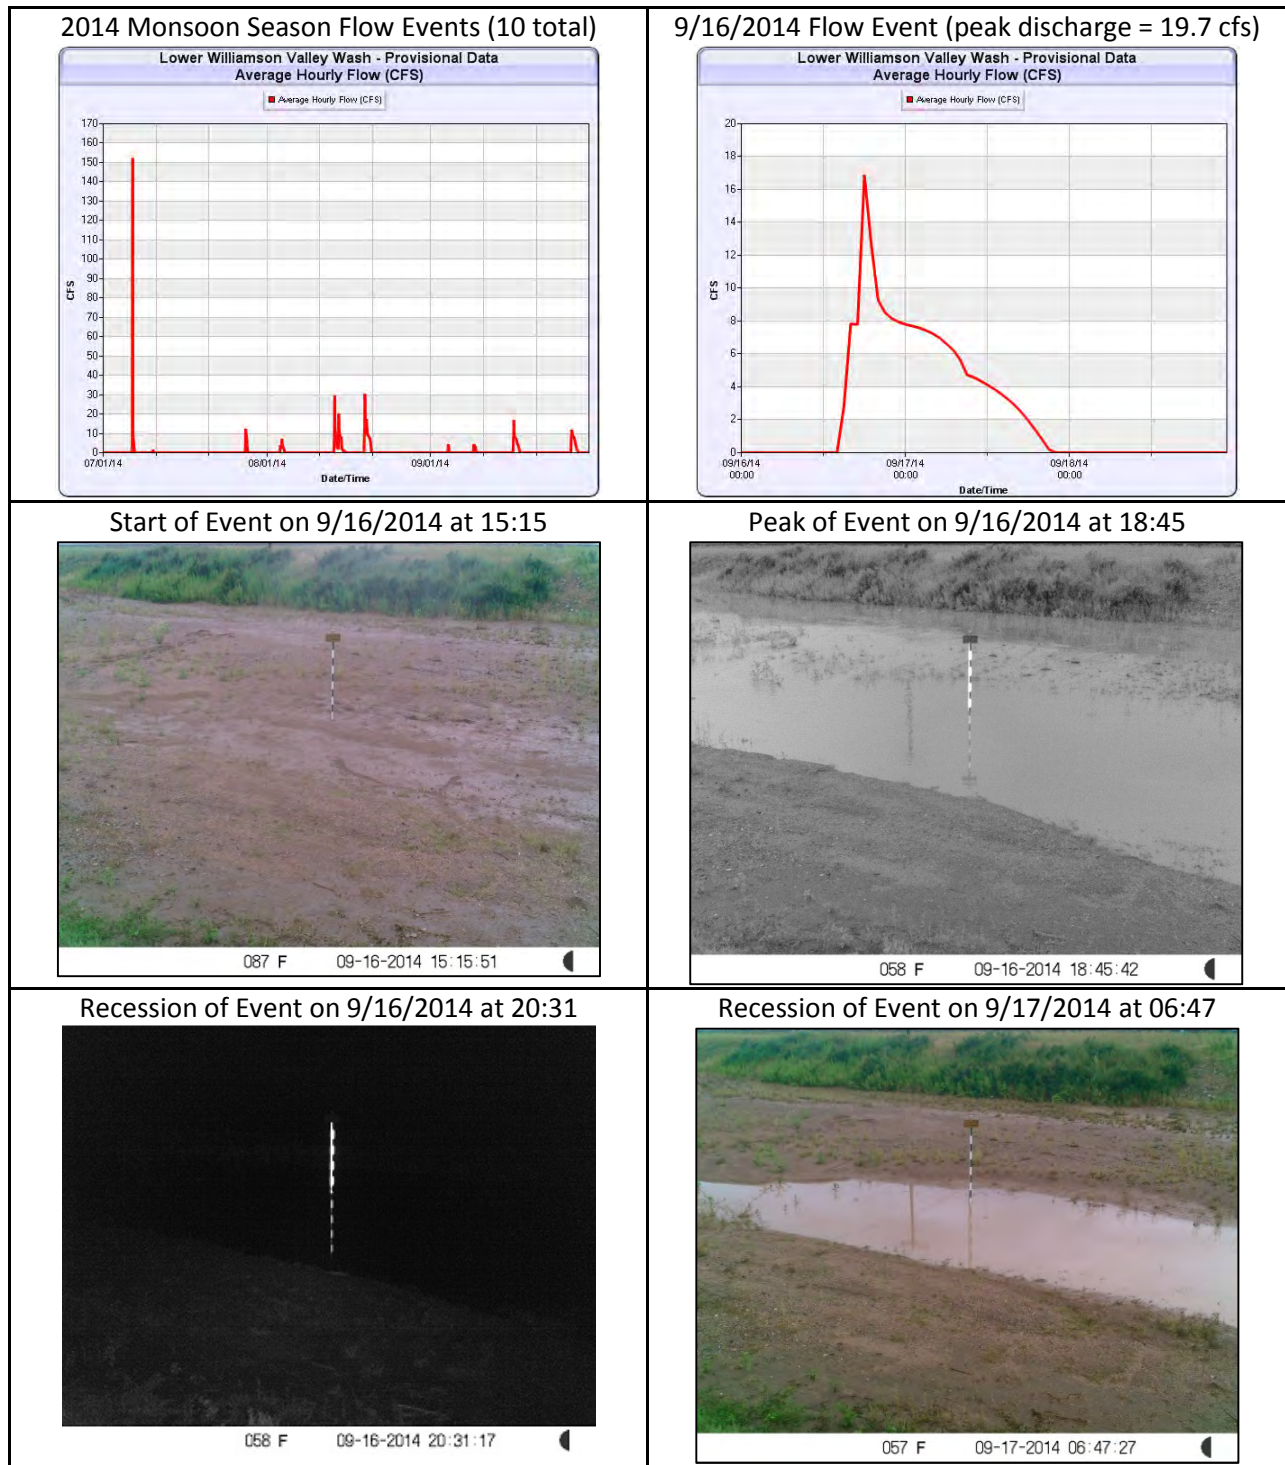
Figure 9: Lower Williamson Valley Wash Hydrographs and Flowtopgraphy Flow Event Images

A total of 10 flow events were recorded at Lower Williamson Valley Wash (LWVW) during the period from July 1, 2014 through September 30, 2014. Peak discharge during events ranged from 4.07 CFS on 7/10/2014 to 281 CFS on 7/6/2014. Total volume of each event ranged from 0.16 AF on 7/10/2014 to 28.1 AF on 8/19/2014. A total volume of 128.23 AF was estimated to flow through the LWVW location during the 2014 monsoon season.

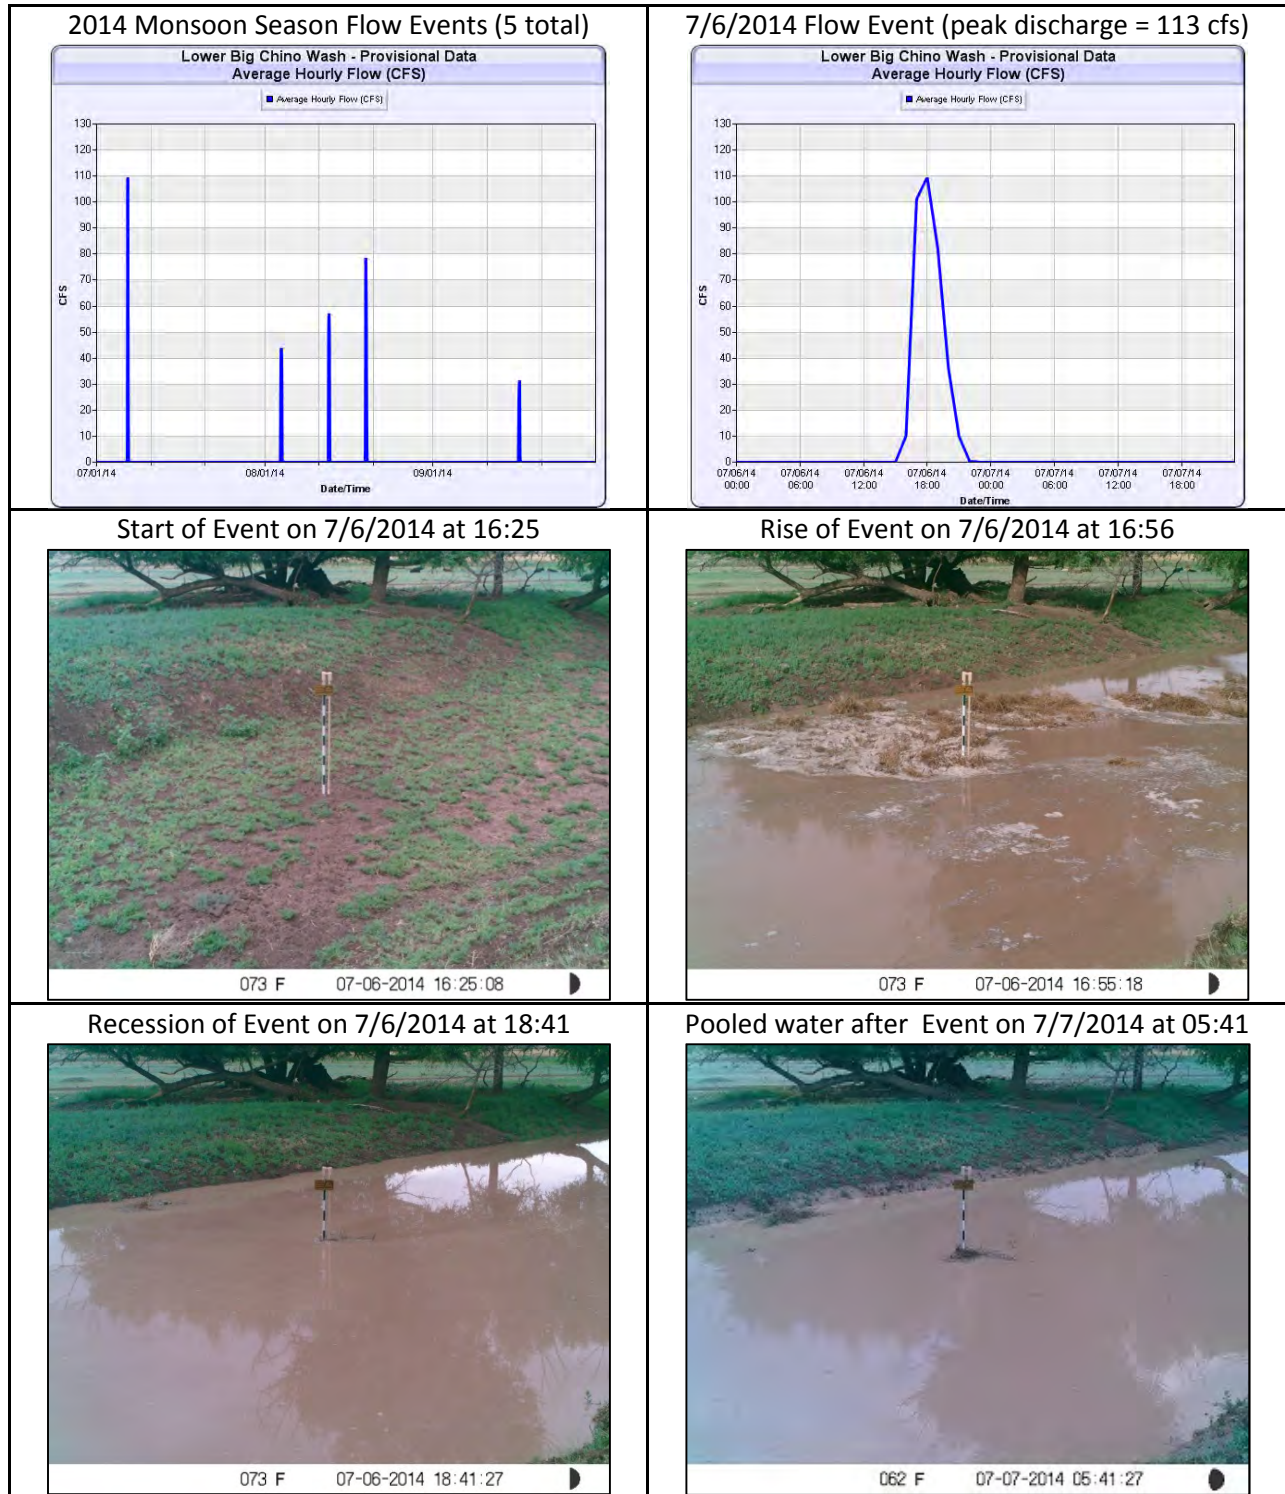
Figure 10: Lower Big Chino Wash Hydrographs and Flowtopgraphy Flow Event Images

A total of 5 flow events were recorded at Lower Big Chino Wash (LBCW) during the period from July 1, 2014 through September 30, 2014. Peak discharge during events ranged from 31.4 CFS on 9/16/2014 to 113 CFS on 7/6/2014. Total volume of each event ranged from 14.12 AF on 9/16/2014 to 31.17 AF on 8/19/2014. A total volume of 121.79 AF was estimated to flow through the Lower Big Chino Wash location during the 2014 monsoon season.

- Cleaned debris from event gages and removed vegetation from banks that obstruct flowtography view
- Took photos with tagline (reference) to determine stage level in images with obstructed gage
- Troubleshoot and repair camera issues
- Investigated and surveyed downstream of event gage in order to adjust rating equation to account for pooled water due to downstream control toward Sullivan Lake.

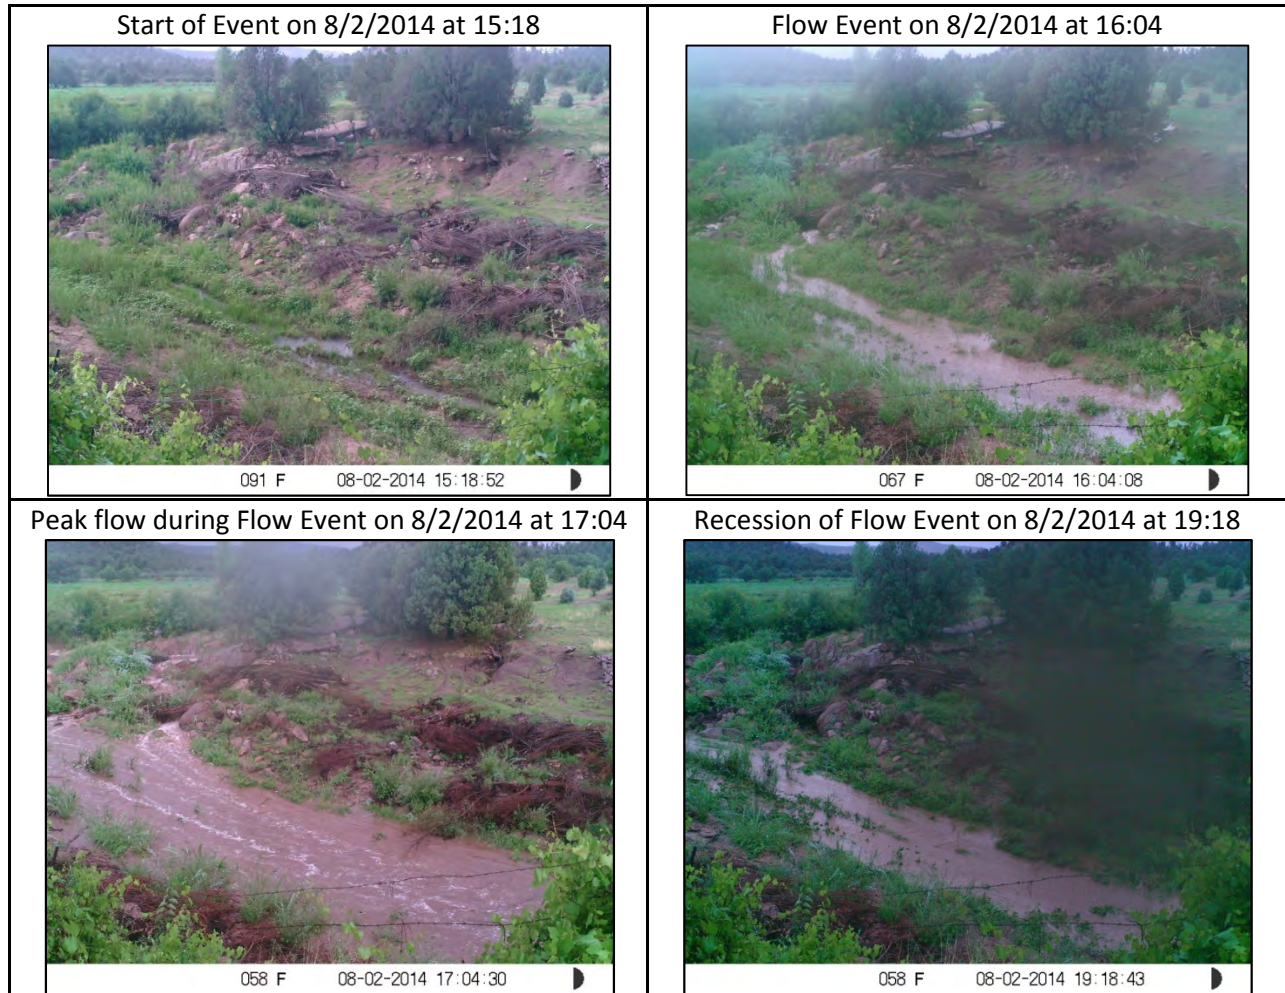
Figure 11 – Upper Walnut Creek at Bridge Flow Event Flowtography Images

A total of 6 flow events were recorded at the Upper Walnut Creek at Bridge (UWCB) location during the 2014 Monsoon Season. The UWCB location is only equipped with a flowtography camera. No transducer or event gages exist, therefore stage and discharge data are not available for this location. No flow measurements were made at the UWCB location during the 2014 monsoon season.

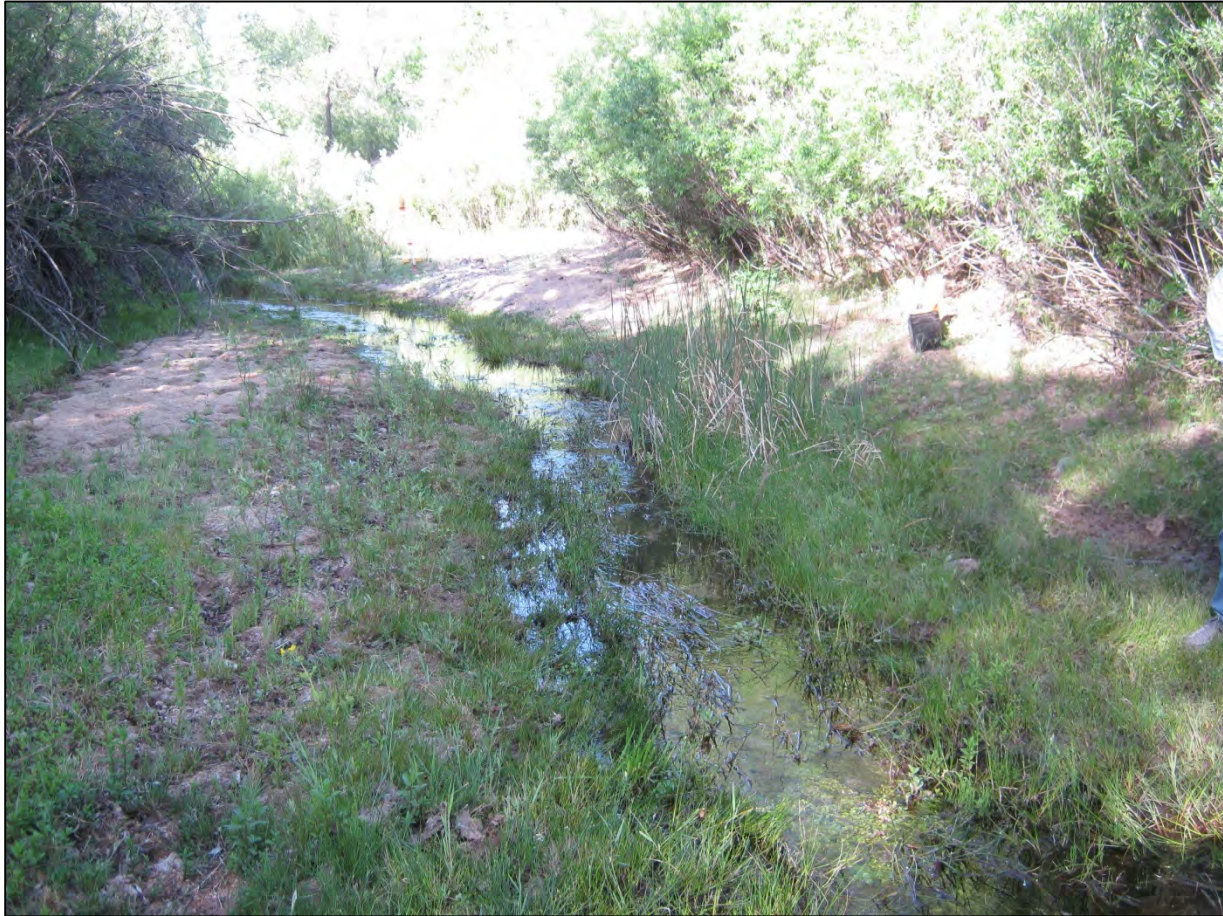
Figure 12 –Upper Walnut Creek at Forest Service Location

The Upper Walnut Creek at Forest Service (UWCFS) location monitoring equipment was not installed prior to the 2014 monsoon season and the site was not visited during this period. Installation of a low flow flume (rated for 2.0 CFS max) and flowtography camera at the site occurred on October 2, 2014. Details on the flume installation and data collected at the UWCFS location will be detailed in the 2014/2015 Winter Season Report. Figure 12 shows the UWCFS location on June 5, 2014.

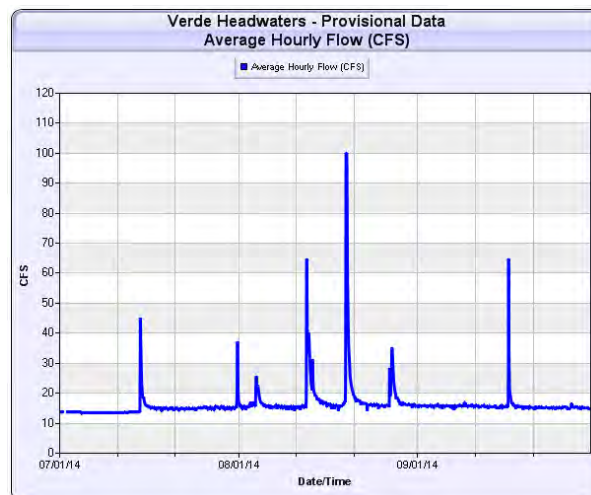
Figure 13 – Verde Headwaters Hydrograph: 2014 Monsoon Season Flow Events (7 total)

Flow events during the 2014 Monsoon season were typical of summer monsoon flash floods consisting of high flows with a short duration with some sites recording smaller flows. Peak discharge reached as high as 640 CFS (BCWPC) and flows varied by location. Stream stage of approximately four feet (or less due to tumbleweeds stuck on gage) were observed to damage (knock over or loosen) event gages at UBCW, BCWPC, and LWCCP. Several of these sites required additional non-routine maintenance and repair due to damage from monsoon flood events, faulty cameras or weak cellular signals, and damage by animals (i.e. cows at LWCCP). Additionally, due to the short duration and flash flood nature of the flow events, conditions were not conducive to current meter measurements during this period. While stage values are typically accurate during flow events, discharge values are based on estimated ratings developed from the modeled cross sections. Direct current meter measurements of flow would be needed to improve accuracy of discharge values in the future. Shifts to rating equations only occurred at UBCW during periods where channel fill were observed above the zero stage level of the event gage.

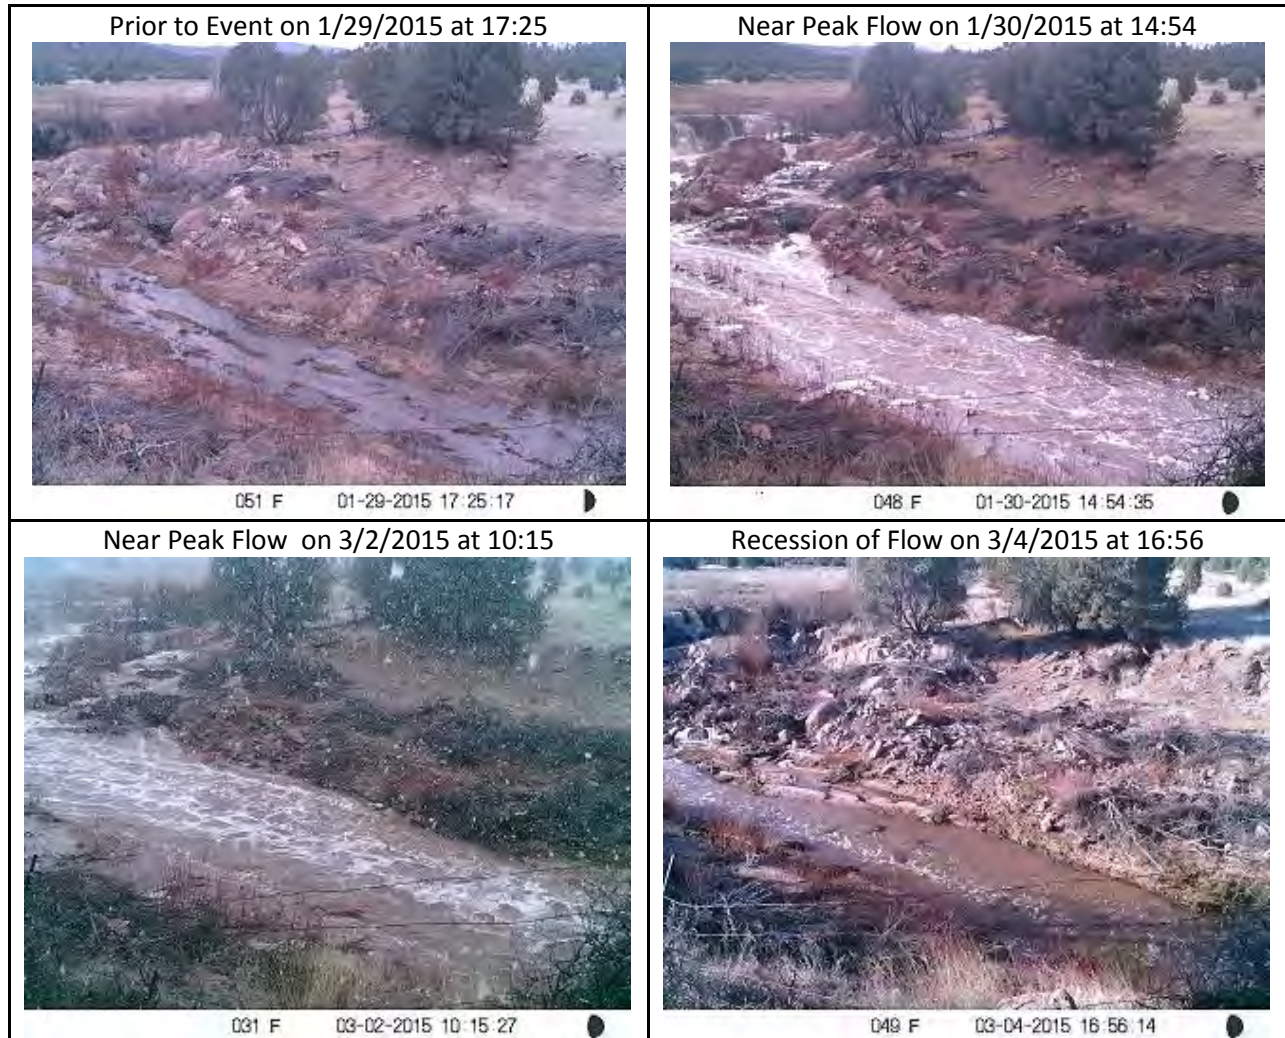
Figure 6 – Upper Walnut Creek at Bridge Flow Event Flowtopography Images

High flow events occurred on 1/30/2015 and 3/2/2015 (Figure 6), with duration of approximately 72 to 96 hours, respectively. The UWCB location was visited a total of nine times during the 2014-2015 winter/spring reporting period for routine maintenance and flowtopography image collection. Site visits on 1/7/2015, 2/10/2015, 3/25/2015, and 4/27/2015 also required replacement or repair of batteries or camera due to being inoperative.

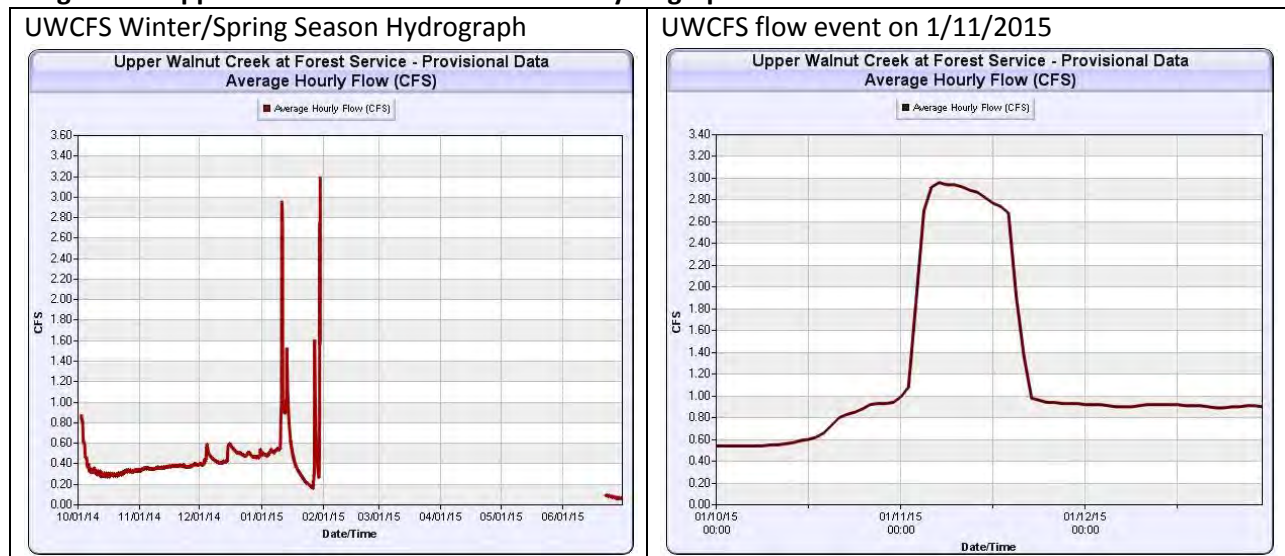
Figure 8 – Upper Walnut Creek Forest Service Hydrographs

A total of 3 high flow events occurred at the Upper Walnut Creek Forest Service (UWCFS) location between October 1, 2014 and June 30, 2015 (Table 4 and Figure 8). The first event occurred on 1/11/2015 and reached a peak discharge of approximately 3 CFS but did not exceed the flume capacity. The events on 1/30/2015 and 3/2/2015 both exceeded the flume capacity and the flume equipment was dislodged from its position in the channel. As a result, peak flows during these events and low flows following 1/30/2015 were not measured. Figure 9 shows flowtography images during three flow events. Small increases in low flow (tenths of a CFS) were also noted on 12/4/2014, 12/15/2014, 12/31/2014, 1/13/2015, and 1/27/2015. Low flow between installation and the first high flow event on 1/11/2015 steadily increased from a low of 0.27 CFS (0.6 AF/day) on 10/2/2014 to a high of 0.54 CFS (1 AF/day) on 1/10/2015 with small increases in flow as noted above. Approximately 102 AF were estimated to flow through the UWCFS location between 10/2/2014 and 1/29/2015 prior to it being dislodged.

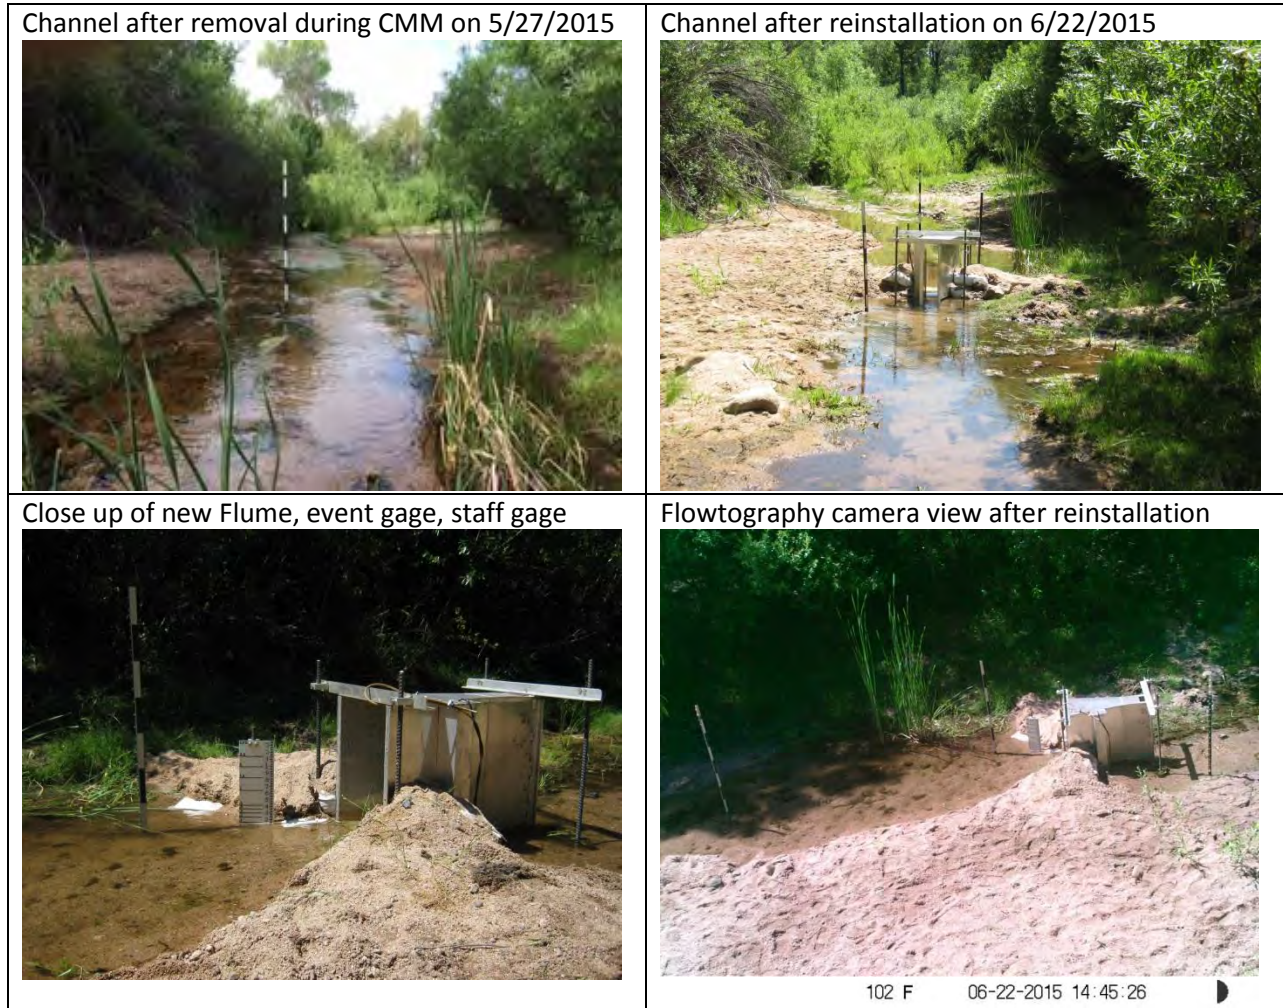
Figure 10 – Upper Walnut Creek Forest Service Flume Reinstallation

Due to damage from high flow events, the flume was removed from the channel on 3/27/2015 and the site was restored to the natural state. A new pressure transducer and event gage was installed in the channel that could be used to support flowtography image processing during a flow event. CMMs were

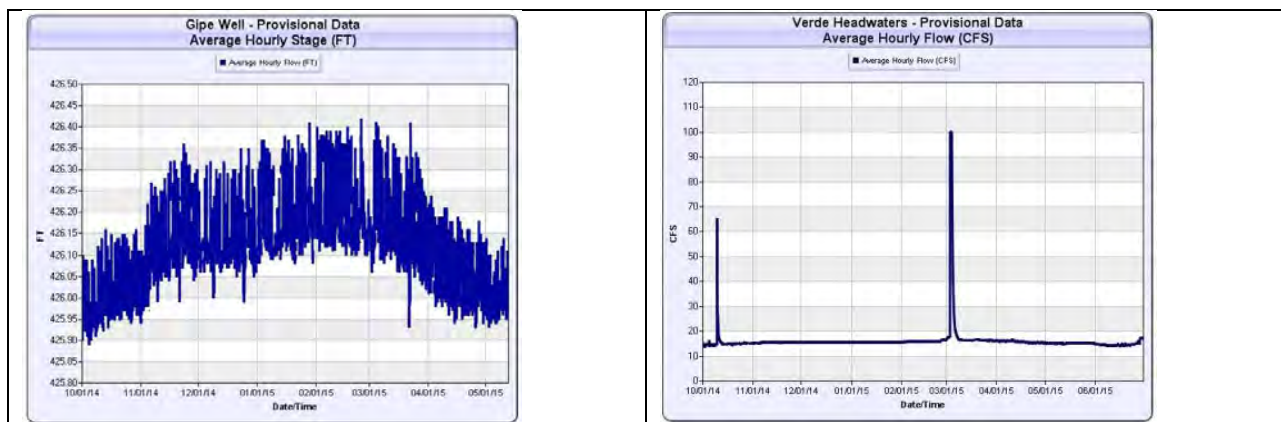
Figure 18 – Gipe Well (depth to water in feet) and Verde River at Campbell Ranch (CFS) Hydrographs

VRCR gage measures low flow (<100 CFS) along the Verde River approximately 3 miles downstream of Sullivan Dam. Flow during the Winter/Spring reporting period remained relatively stable at approximately 15 CFS (+/- 1 CFS fluctuations) with the exception of two high flow events (Figure 18). A total of approximately 248 AF were recorded to flow through the LBCW location just upstream of Sullivan Dam. For the two flow events recorded at LBCW, spikes in flow at VRCR were observed during both of these events on 10/9/2014 and 3/2/2015.

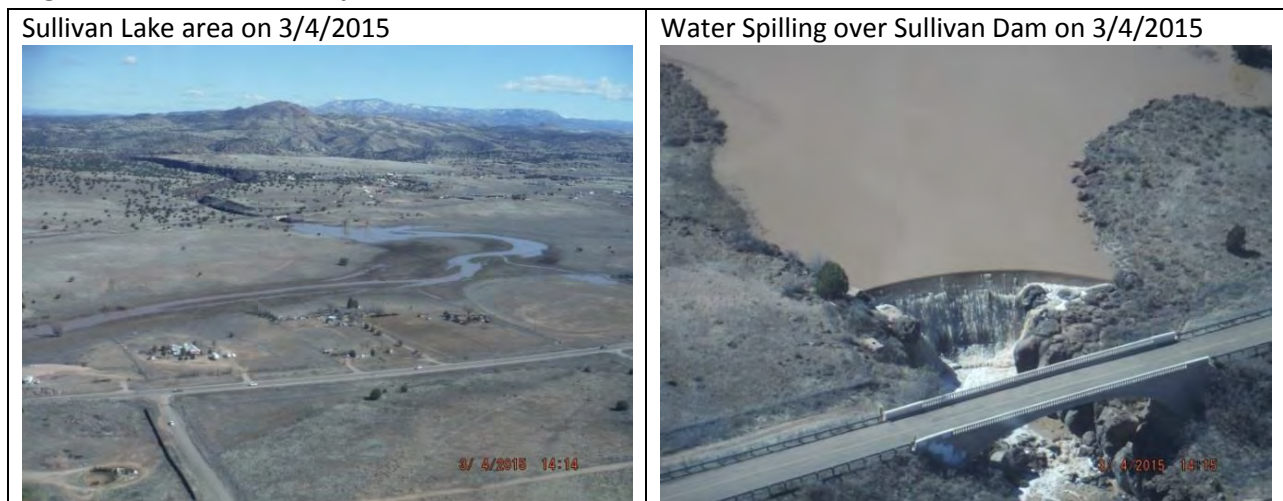
Figure 20 – Sullivan Lake Spill on 3/4/2015

Sullivan Dam was not monitored during this period; but a site visit on 3/4/2015 confirmed that water from Sullivan Lake spilled to the Verde River Canyon as a result of the 3/2/2015 flow event (Figure 20) indicating surface water contributions to the Verde River from the Big Chino sub-basin. Without monitoring of Sullivan Dam and Granite Creek, the contributing amount of flow seen at the VRCR location during events is uncertain.
