# Comprehensive Agreement No. 1

## Third Annual Report

(July 1, 2015 – June 30, 2016)

BIG CHINO SUB-BASIN  
WATER MONITORING PROJECT  
PRESCOTT - PRESCOTT VALLEY - SRP

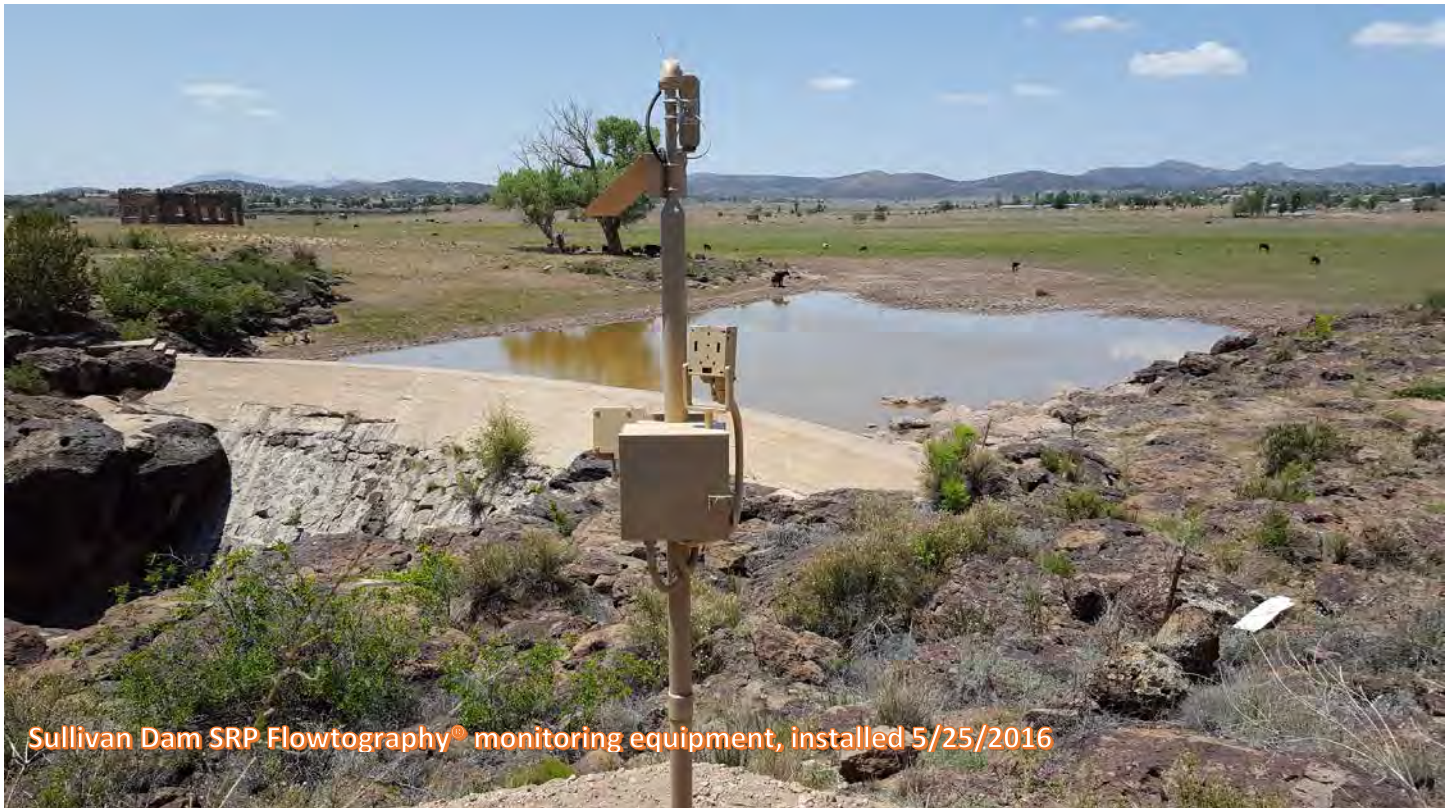
Sullivan Dam SRP Flowtography® monitoring equipment, installed 5/25/2016

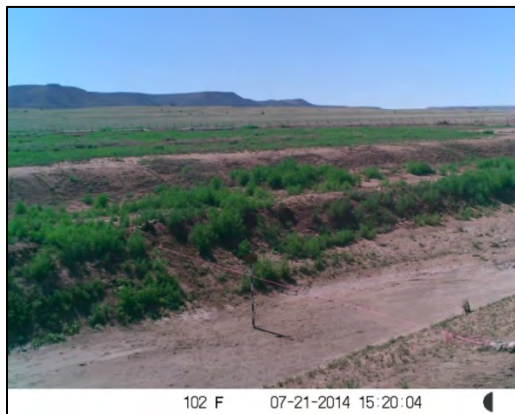
Figure 1. Upper Big Chino Wash tagline reference.

Data processing of stage values and rating curves were completed using Aquarius (version 3.5) time series software. Stage values (feet) collected from the upstream transducer serve as the primary data source (downstream transducer serve as secondary). Offsets to stage values were applied based on the depth of the transducer below the stream channel and then compared with the visual determination of stage values from SRP Flowtography® images. For instances when the event gage was obstructed or missing from the SRP Flowtography® images, stage level overlays were created using a tag line reference at each location (see Figure 1 and Figure 2).

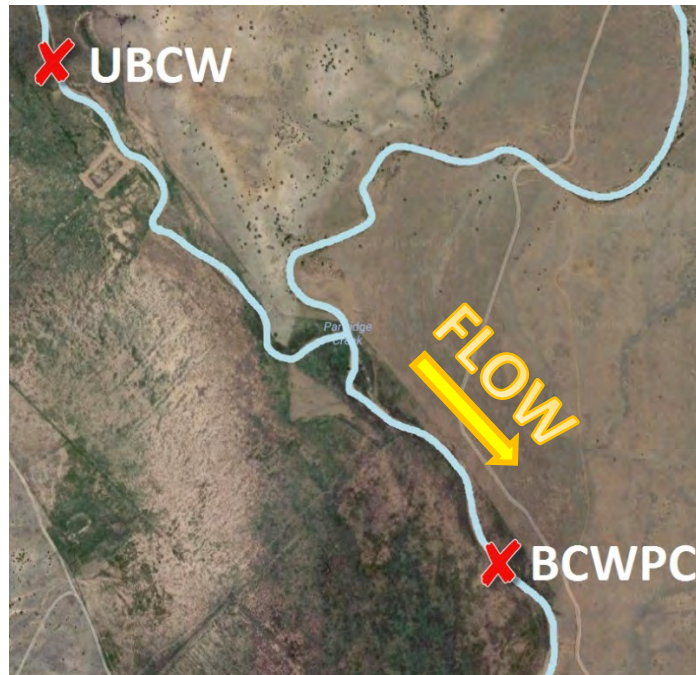
Figure 6: Partridge Creek in relation to UBCW and BCWPC monitoring locations

Partridge Creek originates in McIntyre Canyon and joins the Big Chino Wash north of the BCWPC gage, and downstream of the UBCW gage. The flows at BCWPC can therefore be described as a combination of flows from those observed at UBCW, and those from Partridge Creek (not instrumented). See Figure 6 for a map of the streams and existing monitoring locations. The red 'X' marks on the map note existing monitoring locations.

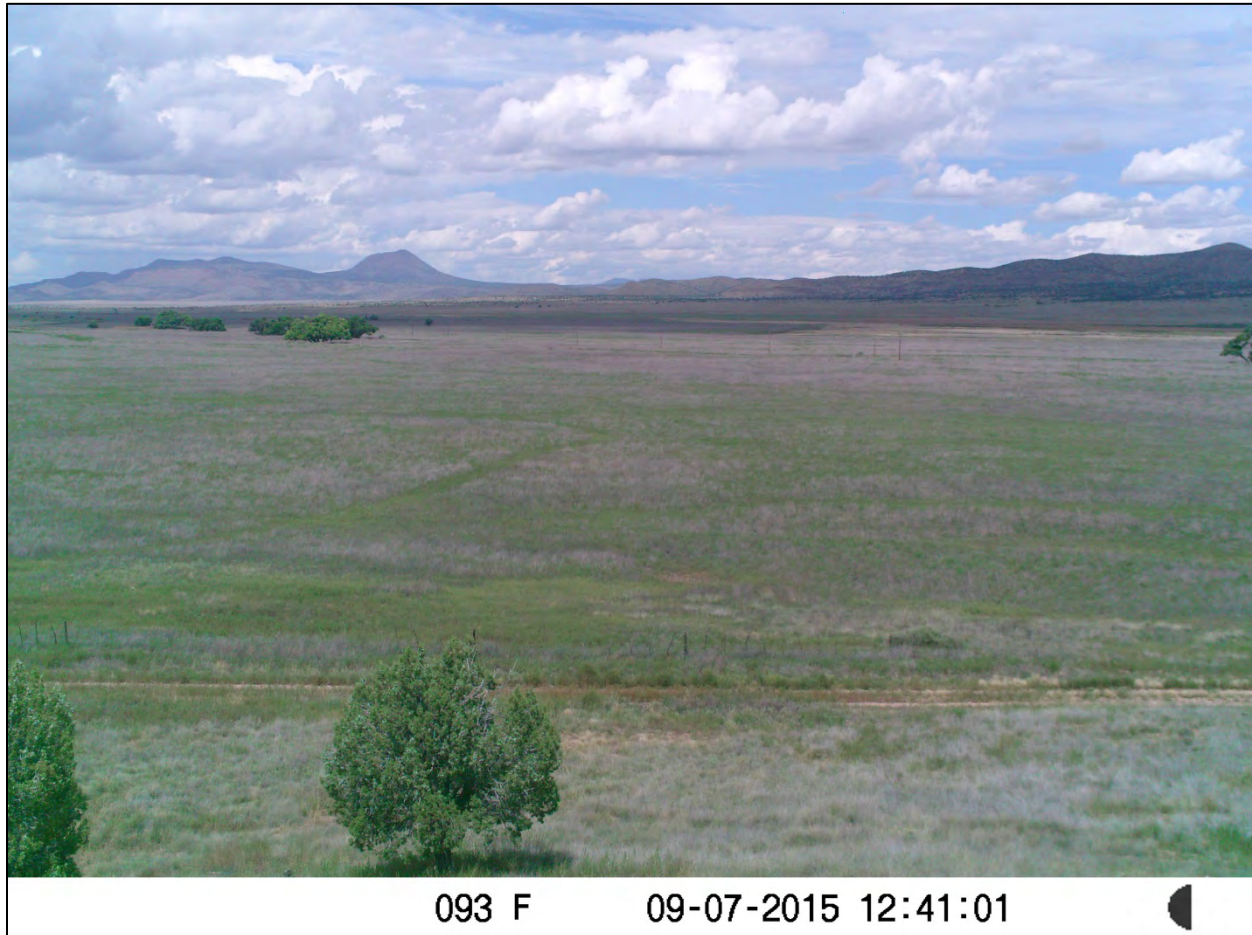
Figure 7: Big Chino Wash at Prescott Ranch SRP Flowtography® Image

On August 26, 2015, a camera was installed downstream of the UBCW and BCWPC monitoring sites on the City of Prescott Ranch property. The site is equipped with a camera only, and the goal of the site is to observe if and when large flow events in the basin result in pooled water. See Figure 7 below for an image from the Prescott Ranch SRP Flowtography® Camera. Of all flow events observed upstream of the BCWPR between July 2015 and June 2016, there were no events that caused pooling of water in the larger area captured by the BCWPR SRP Flowtography® camera only assembly.

- Site connectivity repairs.
- Primary camera replaced with a new g26 time-lapse and PIR mode camera.
- Installation of image loss prevention equipment, lithium batteries, and secondary camera.

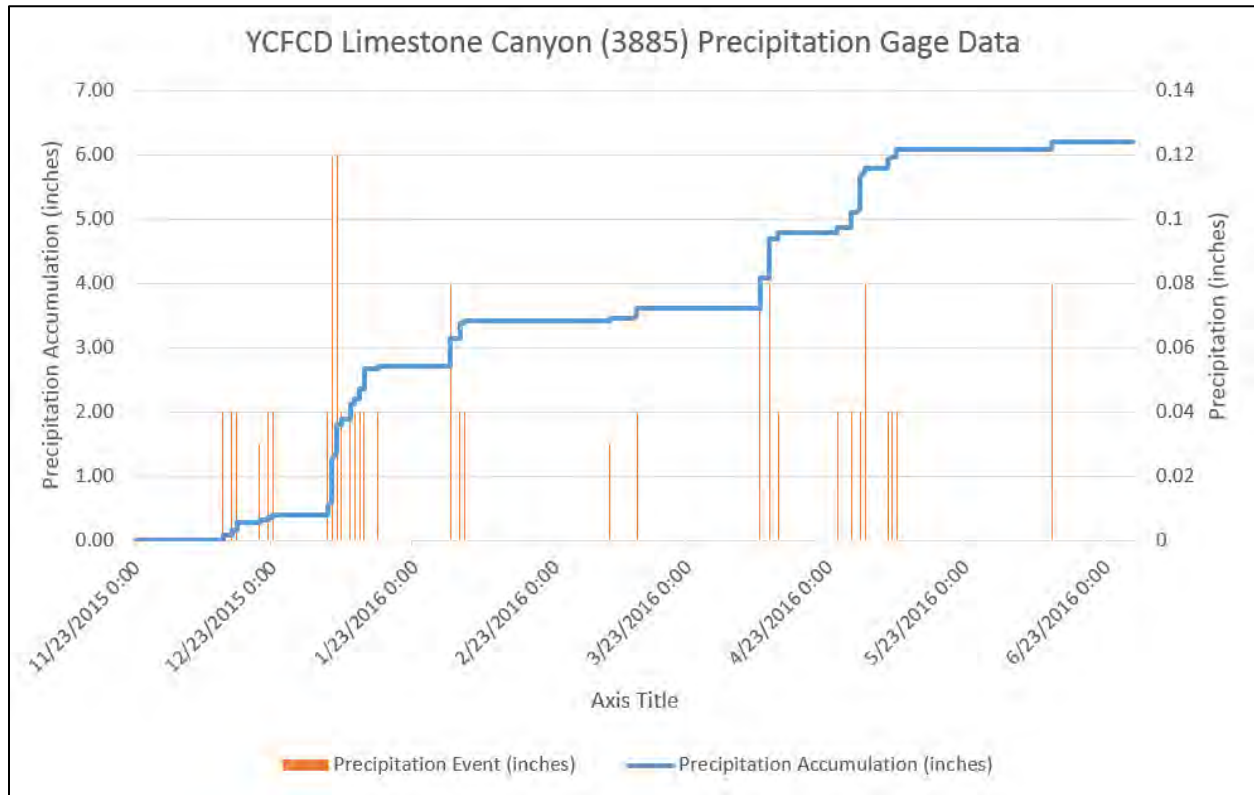
Figure 10: YCFCD Limestone Canyon – November 2015 through June 2016 Precipitation Data (data from [http://weather.ycflood.com:8081/historicdata/pgi\\_historic\\_report.php](http://weather.ycflood.com:8081/historicdata/pgi_historic_report.php))

The YCFCD precipitation gage at Limestone Canyon recorded over six (6) inches of precipitation from the installation date of November 23, 2015 through June 30, 2016 (See Figure 10 for precipitation data).

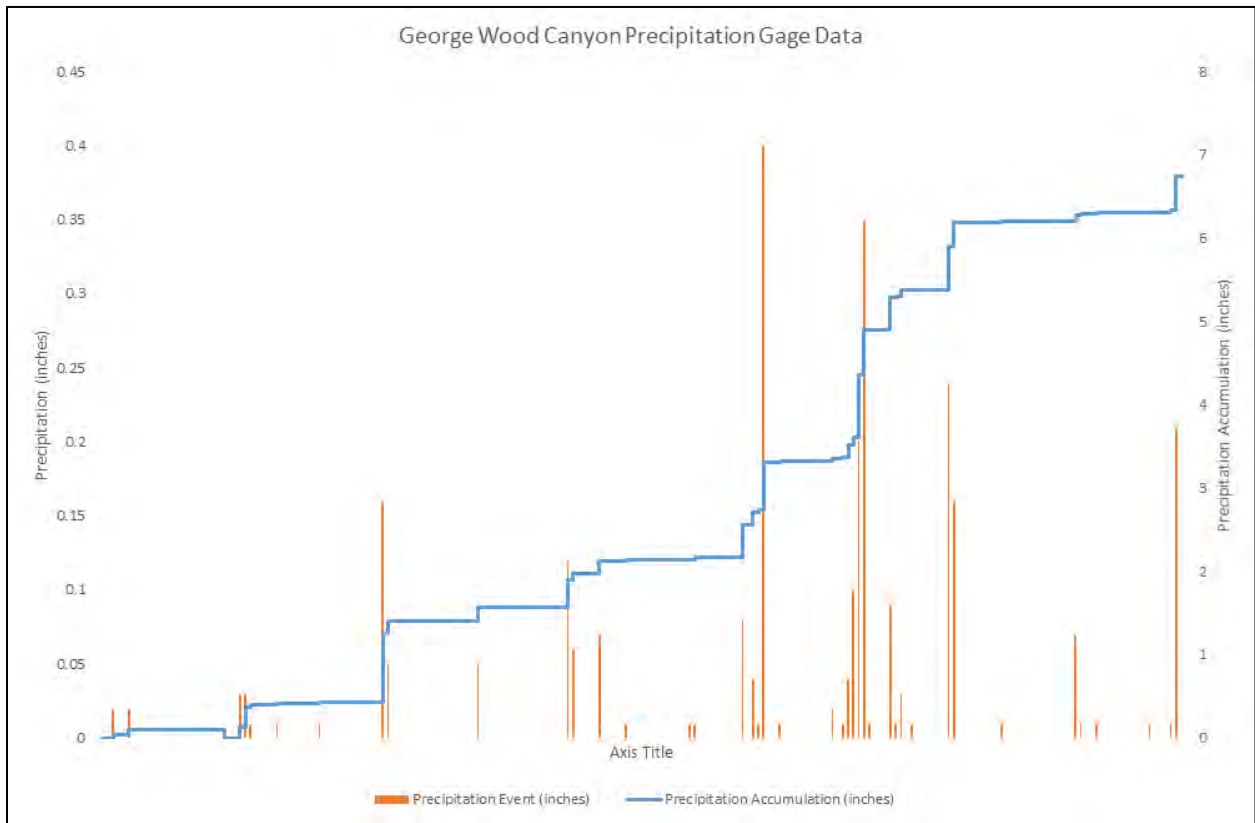
Figure 11: George Wood Canyon - December 2015 through June 2016 Precipitation Data

At the GWC weather station, five (5) snow accumulation events were recorded during the period from July 1, 2015 through June 30, 2016. Snow depth during the reporting period ranged from 0 ft. to 0.28 ft. (Table 7, Figure 11, and Figure 12). It is important to note that these values do not reflect and calculation for snow water equivalence, and during no event was there visible runoff.

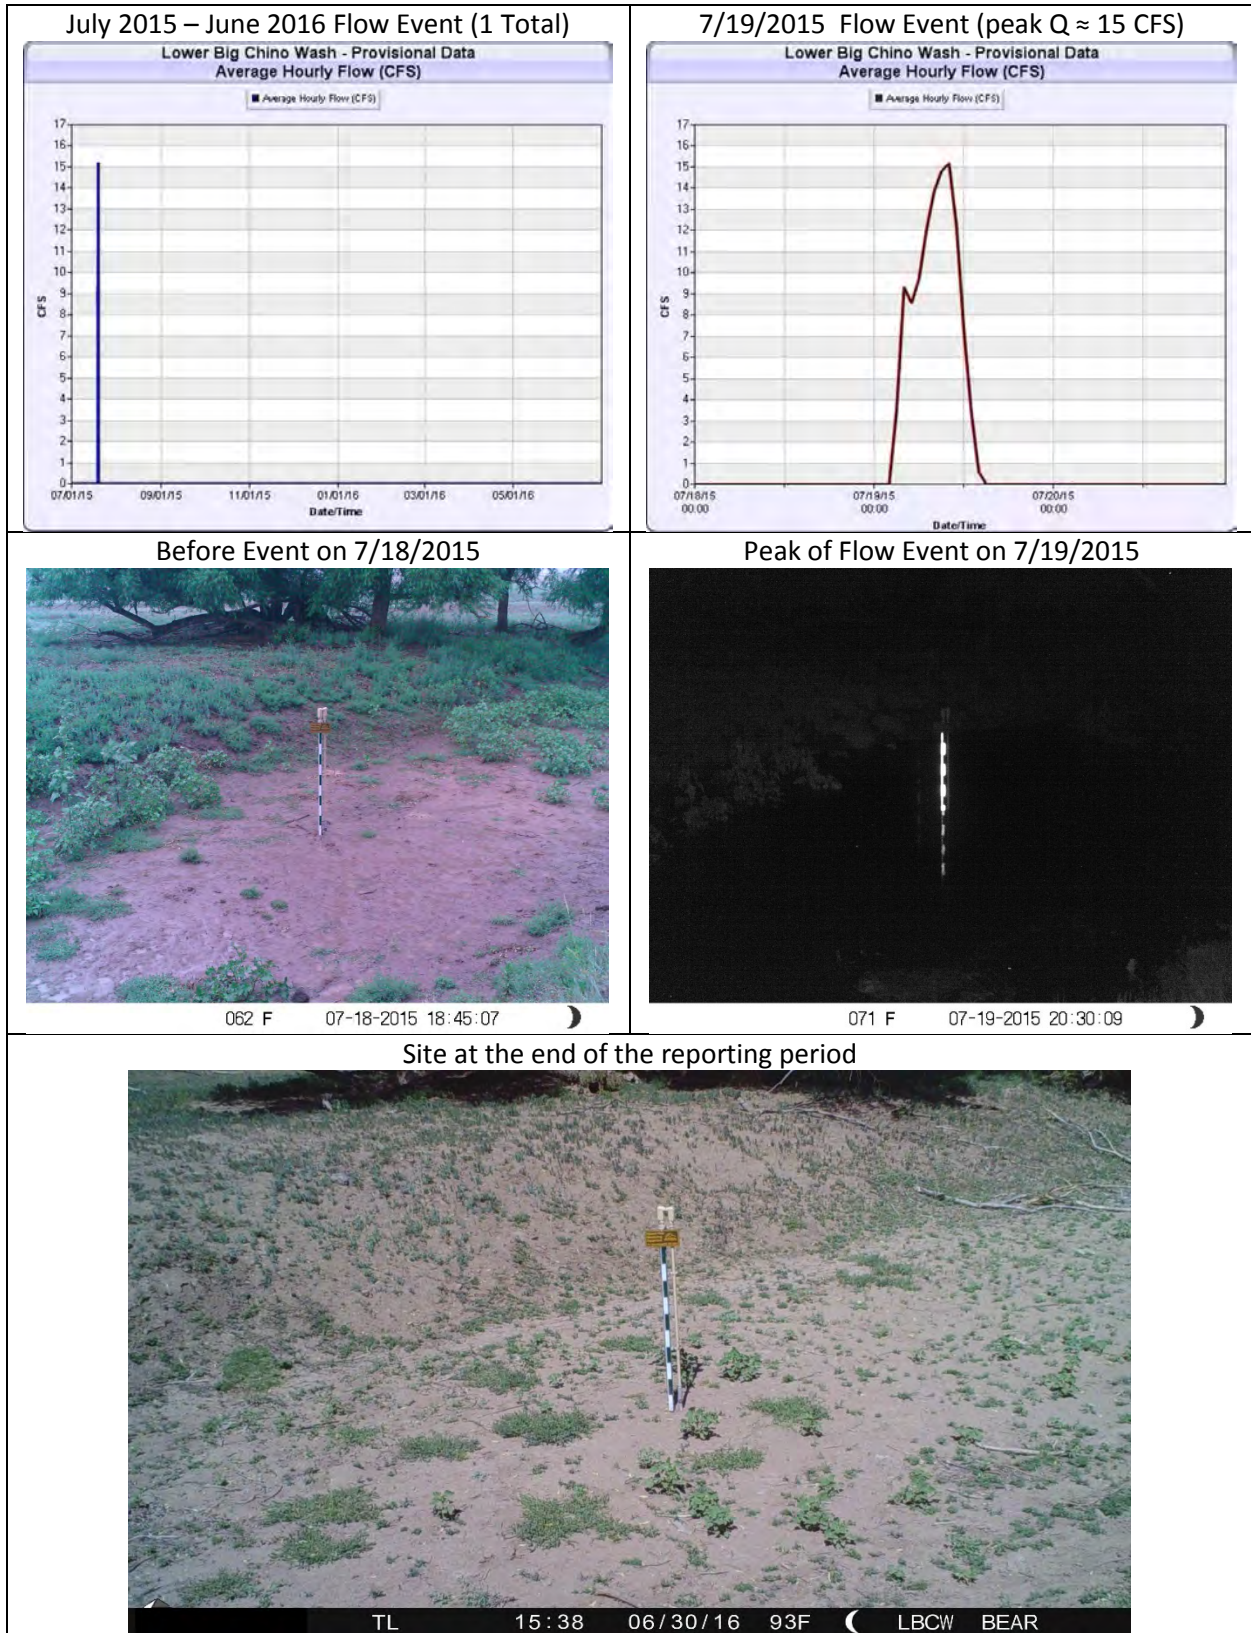
Figure 18: Lower Big Chino Wash Hydrographs and SRP Flowtography® Flow Event Images

One (1) flow event was recorded at the Lower Big Chino Wash (LBCW) site during the period from July 1, 2015 through June 30, 2016. The flow event occurred during the previously reported monsoon period. The one flow event started on 7/19/2015, with an estimated peak stage of 1.4', an approximate peak discharge of 15 CFS, and an approximate total flow of 9 AF. Between July 2015 and June 2016 approximately 9 AF were observed at LBCW (See Table 11 and Figure 19).

- Site connectivity repairs.
- Primary camera replaced with a new g26 time-lapse and PIR mode camera.
- Installation of image loss prevention equipment, lithium batteries, and a secondary camera.
- Installation of new pressure transducer housings at the upstream and downstream event gages.

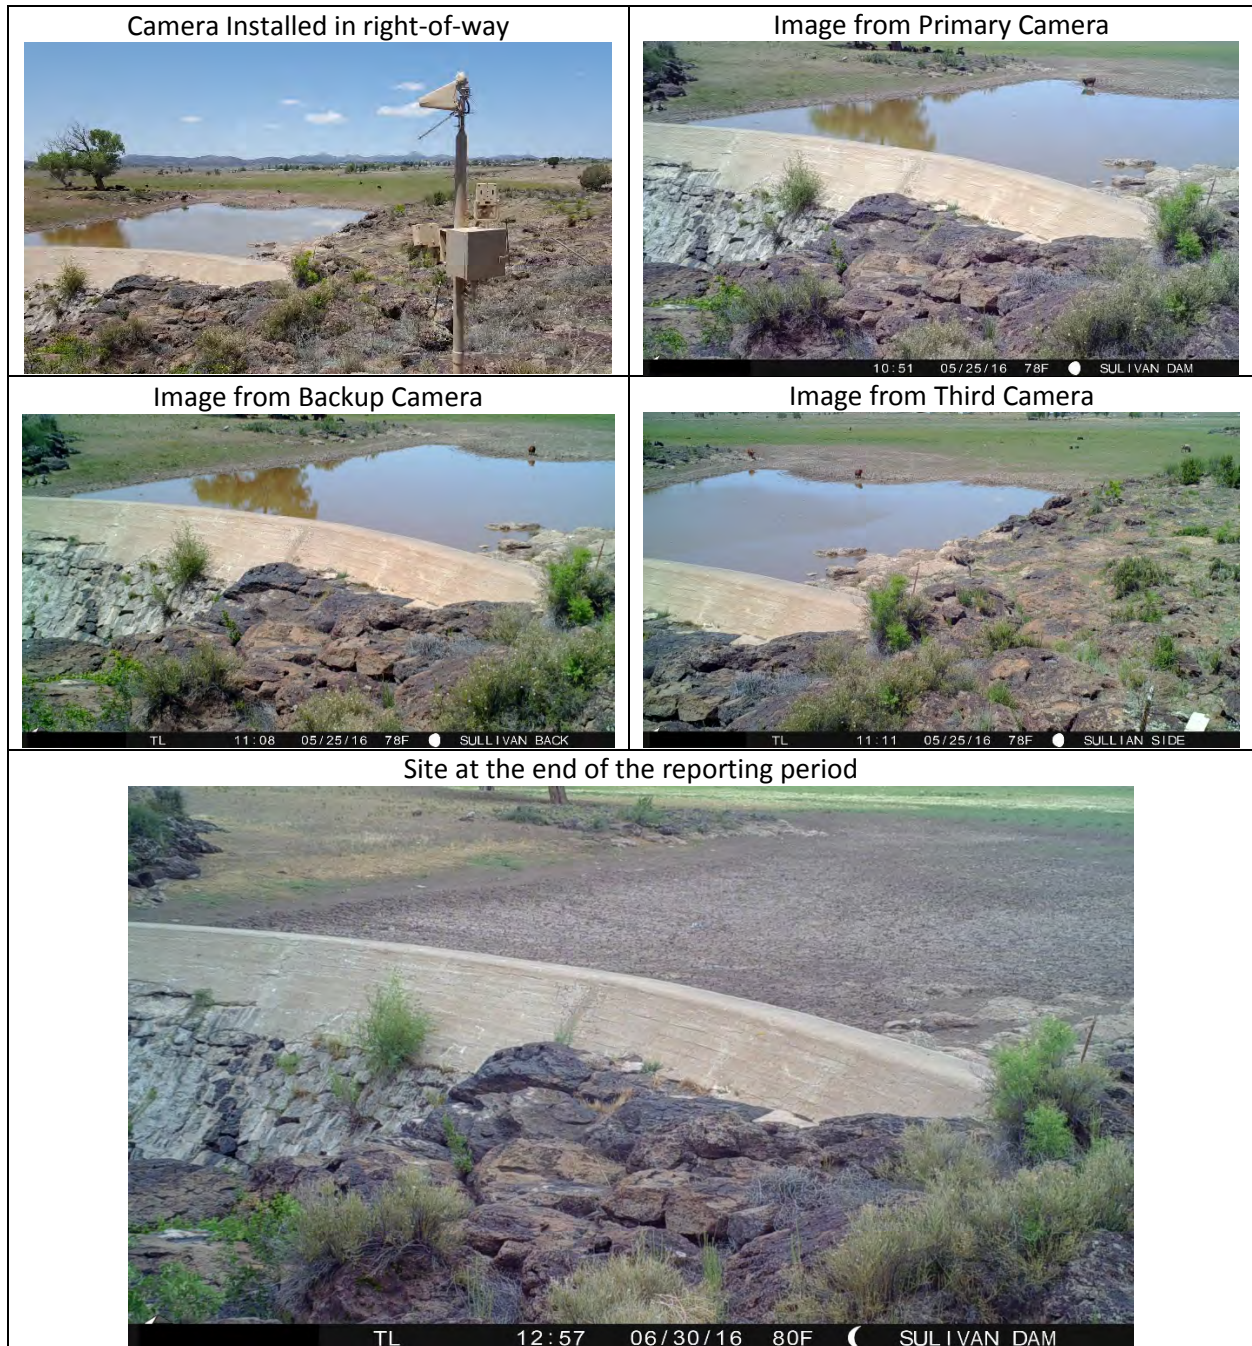
Figure 19: Sullivan Lake Dam SRP Flowtography® Camera Only Assembly Installation and Site Images

On May 25, 2016, a SRP Flowtography® camera only assembly was installed in the right-of-way on Old Highway 89 facing Sullivan Lake Dam (see Figure 20). Three cameras were installed to collect 15 minute images of the dam. The purpose of the site is to record any periods of flows from Lower Big Chino spilling over the dam, and potentially contributing to the Verde Headwaters at Campbell Ranch (VHCR) gage. No flow events were capture after the installation date during the July 2015 through June 2016 reporting period

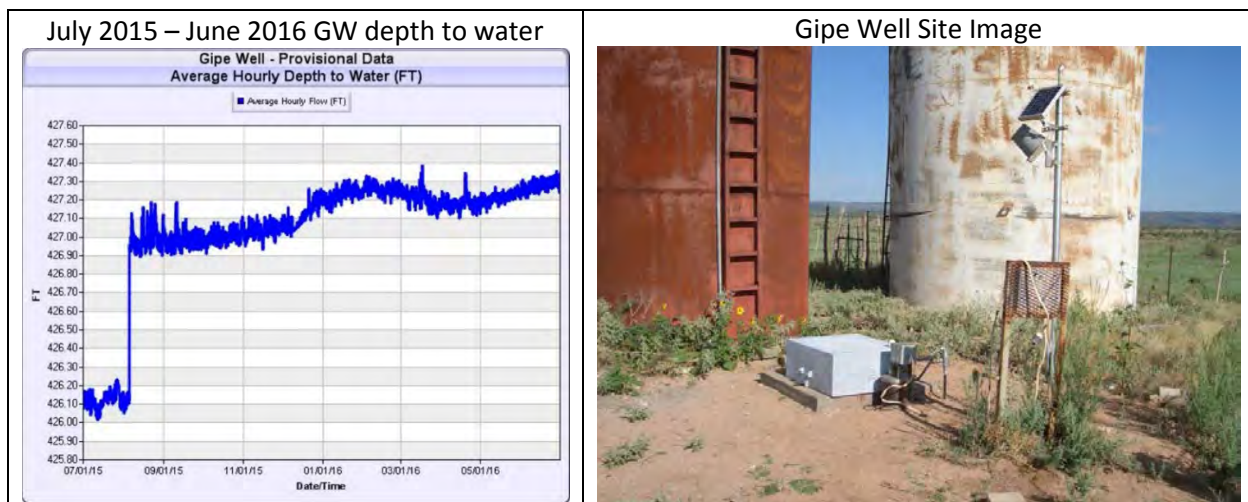
Figure 21: Gipe Well Hydrograph (depth to water in feet) and Site Images

The Gipe Well (GW) location records the depth to water (stage in feet below land surface) and is located in the southeastern portion of the sub-basin approximately 7 miles northeast of Sullivan Sam.

During May 2015 the pressure transducer started exhibiting scaling issues. On August 5, 2015 the pressure transducer was replaced with a new one resulting in an adjustment going forward. On August 14, 2015 another well sounding was completed to verify that the adjustment was correct.

- Replaced the pressure transducer with a new one.
- Conducted a well sounding to verify the pressure transducer readings.
- Replacement of the battery at the site.

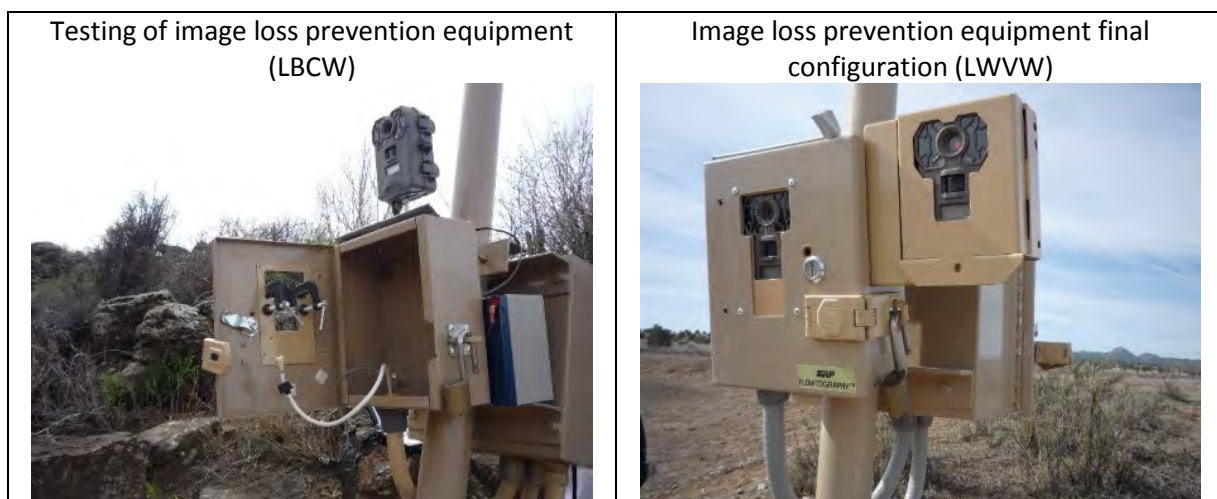
Figure 22: Equipment modifications at Big Chino SRP Flowtography® locations.

Equipment modifications were facilitated at all SRP Flowtography® stations during the July 2015 through June 2016 annual reporting period. Pressure transducer housings were removed and replaced with a more efficient and enhanced design. The new design will allow for water to flow more freely within the pressure transducer housings for more responsive pressure sensor data.

Primary cameras were replaced with the newest model g26 style camera, and image loss prevention equipment with secondary cameras and lithium batteries were installed (See Figure 23). Primary camera settings were changed to take images every hour. Due to the cellular connection in the area, the cameras often got tied up transmitting the 15 minute images. This hourly setting was to reduce the amount of camera errors, and thus reduce the amount of service trips needed to repair the cameras. The secondary camera was set to take the 15 minute images, as well as PIR images of flow. The g26 model was chosen for its simultaneous time-lapse and PIR (Passive Infrared) capabilities. The PIR setting allows for images to be taken when the infrared sensor detects motion. After the cameras were upgraded, settings set to take images every one hour, and secondary cameras installed, there have been no service trips to diagnose and repair camera transmission issues.

- Equipment modifications were completed to all upstream and downstream event gages. Each pressure transducer housing was replaced with an upgraded model, which will enhance the response of the pressure transducer readings.
- Captured snow accumulation and runoff in SRP Flowtography® images at multiple locations.
- Installed a SRP Flowtography® camera only assembly at Big Chino Wash at Prescott Ranch and Sullivan Dam.
- Installed a weather station and SRP Snowtography™ assembly at the George Wood Canyon location.

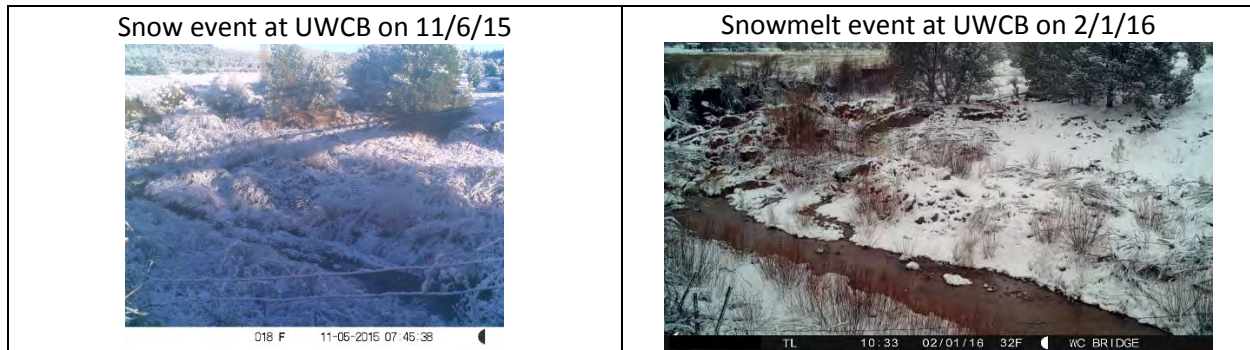
Figure 23: Snow Accumulation Events at Big Chino Sub-basin Sites

Snow accumulation was observed at multiple locations in the sub-basin during the period from July 1, 2015 through June 30, 2016. Maximum snow depths measured at the event gages ranged from 0.36" at LBCW on December 14, 2015 to 3.48" at GWC on January 11, 2016. See Figure 24 for snow accumulation event images from the annual reporting period.

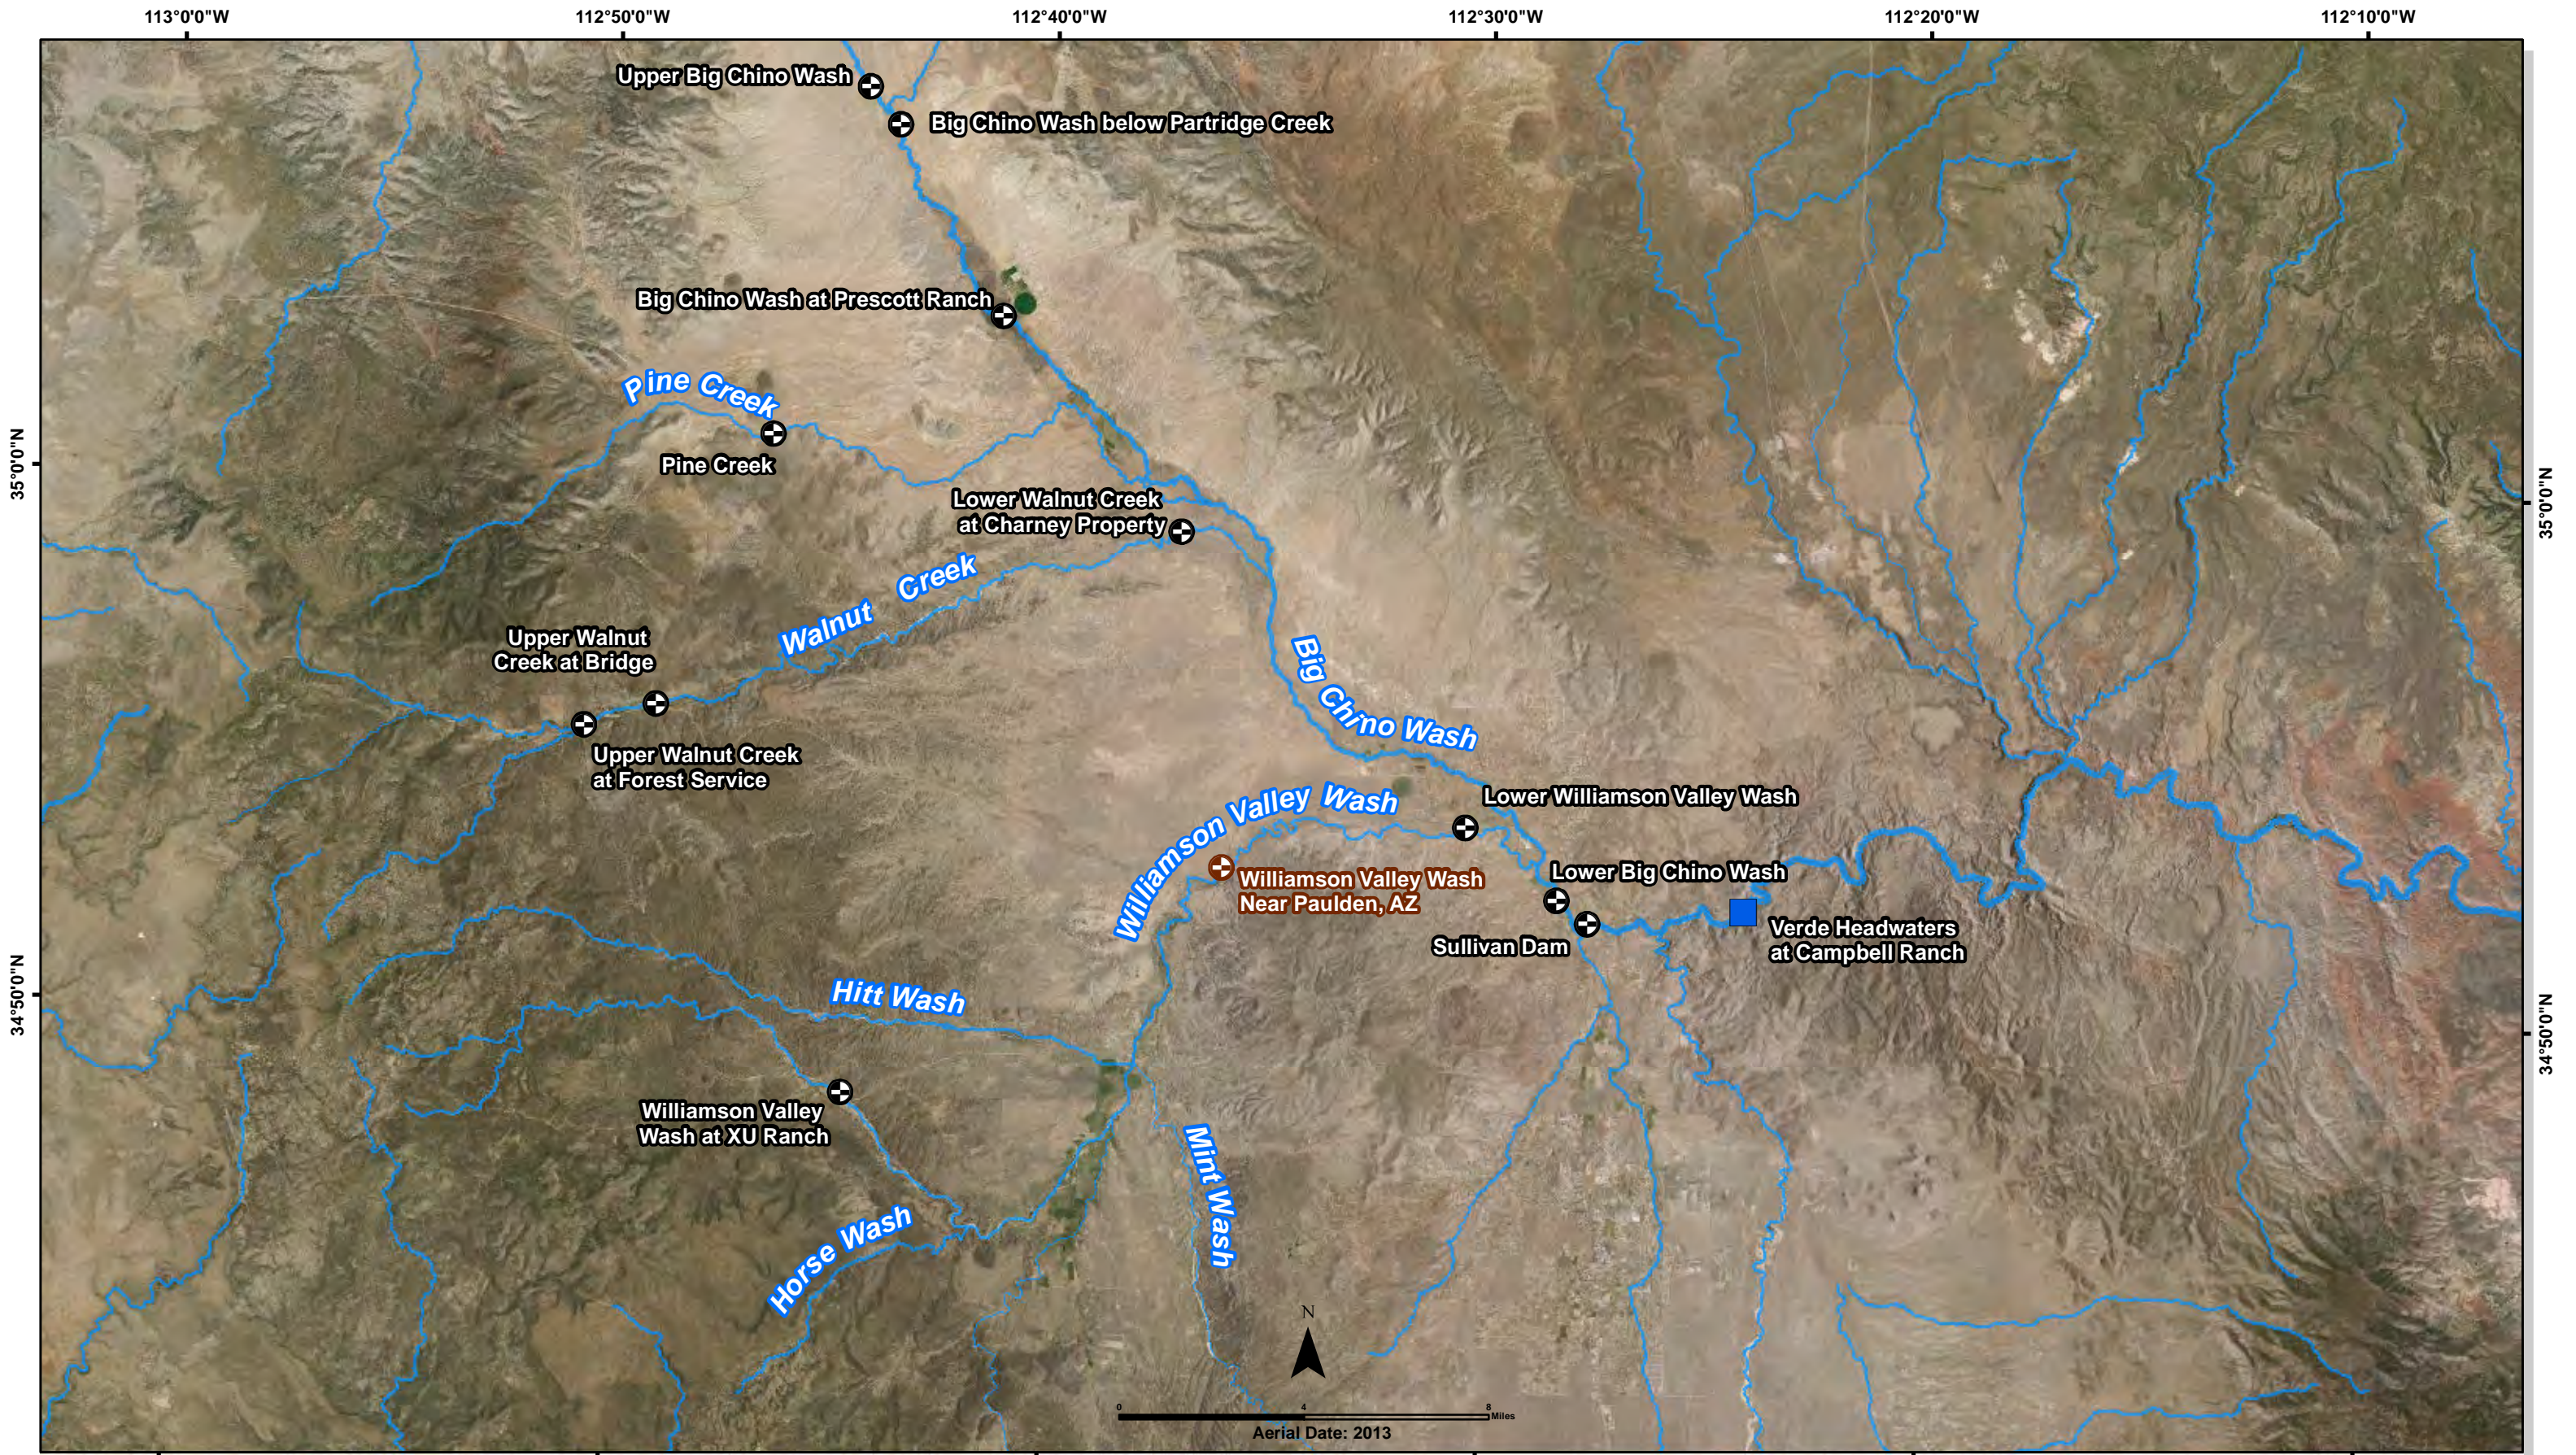
**Map 3**  
**Big Chino Sub-basin - Surface Water Monitoring**  
 (existing flowtopgraphy, camera only sites and Verde Headwaters)

-   Surface Monitoring Location
-   USGS Gauge
-   Verde Headwaters
-   Creeks & Washes
